The Rebuilding of a GM 350

by Ryan Stark

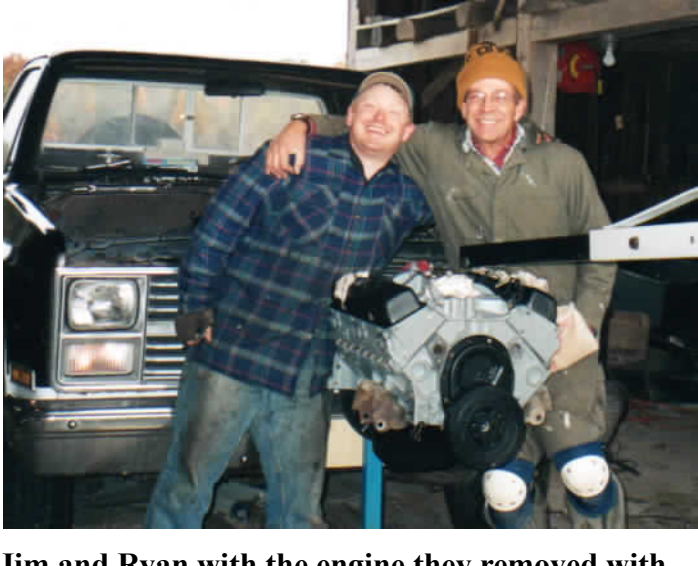
Jim and Ryan with the engine they removed with a puller made for a car. This was just problem #1 in a job that presented many obstacles.

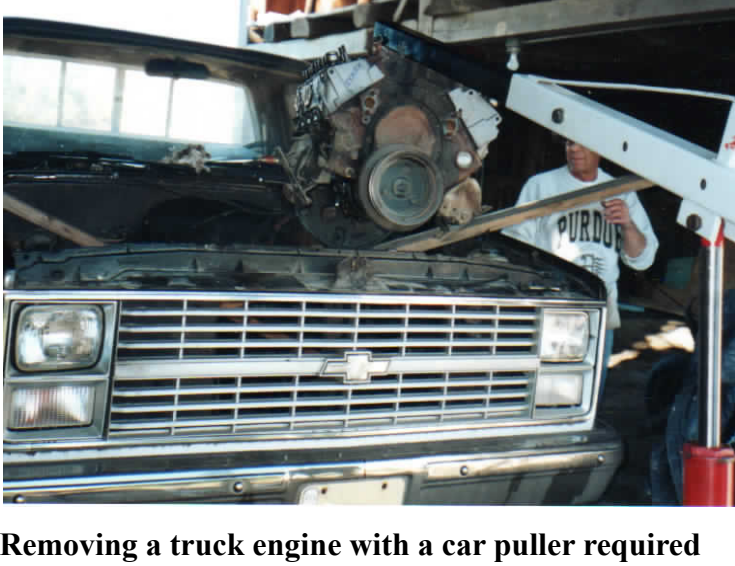
Removing a truck engine with a car puller required 2x4s, ingenuity, and nerve.

After removing the oil pan and finding some scored bearings, I decided to pull the whole engine and do a complete rebuild. So I borrowed an engine puller, got the engine loose, and hooked up the chains, and that’s when I ran into my second problem. The puller I borrowed was made for a car and I could not clear the radiator, even after jacking up the puller as far as it would go. To get the engine out, we had to lower it onto some wood blocks and hook one removable chain link from the puller arm to the webbing between the holds of the carburetor intake. This was a dicey maneuver to say the least, but it worked (see the picture above). I was originally thinking about swapping out the steel intake manifold for an aluminum one, but after seeing the strength of the original steel one, I was too impressed to scrap it.
