Report of the Month

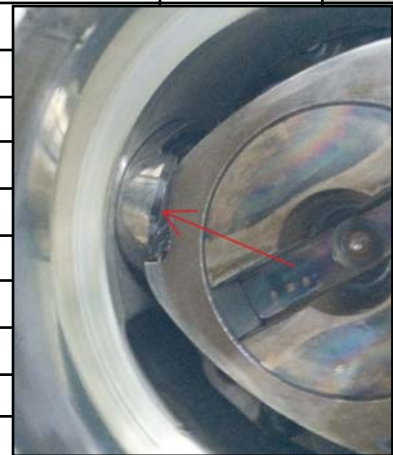
We included a picture of this 2007 VW GTi's 2.0L problem. (It's not covering up any important data.)

“It was driving me crazy about what in the world had gone wrong with iron in this last oil change. Well apparently the cam follower had started to wear a while back, causing the increase in iron. Then after the follower wore completely through during this last oil change, iron shot way up as (I'm guessing) the broken follower started eroding the cam lobe. You can see in the picture the follower that rides along the lobe, which powers the high pressure fuel pump. If you look very closely, there is a black vertical stripe on the edge of the follower; that is the teflon coating, which apparently when gone causes metal-on-metal friction shear, which eventually consumes the follower.”
