Everyone's favorite part of the newsletter is the Report of the Month, so we thought this month we'd give you what you really want to see -- aircraft problems that you don't have to deal with! What follows are four aircraft samples, each with some sort of problem. We have reported what the owner or mechanic told us in the comments below each report. But before you look at the answer, take a minute to study the data. Can you figure out what went wrong?

Report of the Month

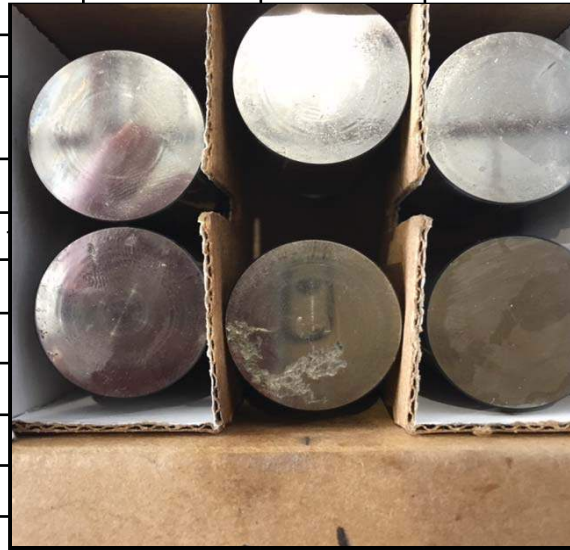
The change in wear is what alerted us to trouble in this IO-550-N. What's the problem?

The mechanic says that when he saw the change in wear, he had the customer bring the engine in right away. "We checked compression, borescope-inspected the cylinders, removed the rocker covers, and inspected the rocker shafts, bushings, and valves. Removed some sample lifters and found the problem. The lifters were just starting to spall and flake. The cam was okay, but I'm sure the iron getting into the oil was causing other metals to wear. We will keep an eye on the next two samples."
