Everyone's favorite part of the newsletter is the Report of the Month, so we thought this month we'd give you what you really want to see -- interesting engines and problems that you don't have to deal with! We'll start with this completely stock '49 Ford running Mobil 1 10W/30 Extended Performance oil, driven by the owner cross-country. He was sampling just to see how bad the engine beat up the oil. The car did not use enough oil to have to add any. It's a non-PCV motor running a stock carb that got hot going through the mountains. See the owner's comments below.

Report of the Month

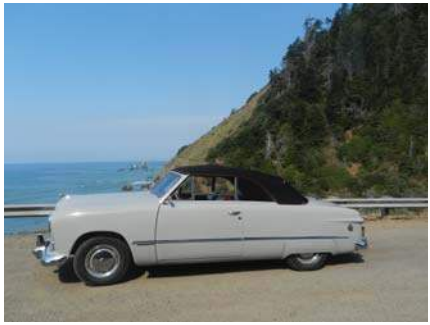
From the owner: In September 2017 I embarked on a trip across The Great Northern Route Two to the Western National Meet of the early Ford V8 Club of America in Salem, Oregon. The route goes from Bar Harbor, Maine to Everett, Washington. Other than a couple of cities it is basically rural -- there may be speed limit signs, but not much else.

From San Mateo I proceeded east through Yosemite National Park and into Nevada. I hit my high point at the Vail Pass at 10,666 feet, and while the car was anemic and vapor-locking a bit as well as overheating, I made it to the top. I cooled on the downhill but still needed a fair amount of water. The rest of the trip was problem-free! Total fuel cost was \$1230 for 431 gallons of fuel. Average mpg for trip was 18.8. The engine is bone stock and I run a GPS off the 6-volt positive ground by floating a power point with the correct DC orientation. All mileage numbers and driving times came from the GPS. Here is a link to my Facebook page:
