Report of the Month

This O-470's trends started getting erratic back in 2016, but it took until 2018 for the problem to become clear. Can you tell what was wrong?

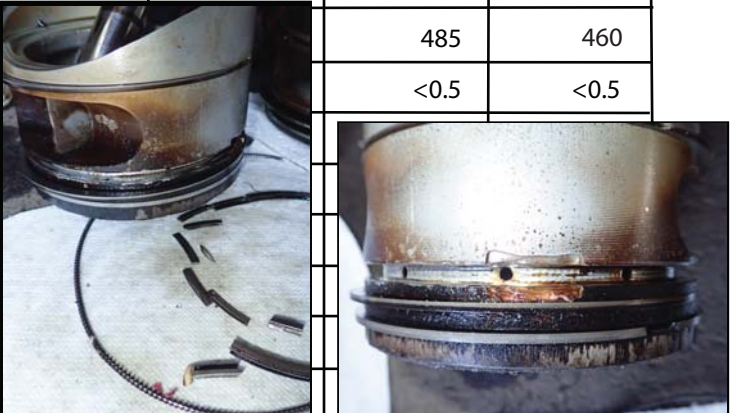
From the owner: We have taken this aircraft out of service now and pulled the cylinders. On the #3 cylinder, the oil scraper ring had failed and was eating up the piston. The valve seals are definitely worn on all the cylinders, and blow-by was marked on inspection. We are now doing a top overhaul on the engine. Thank you for the information.
