# Report of the Month

This 2002 Toyota Avalon had a problem repaired between the first and second samples. So why is wear higher in the second?

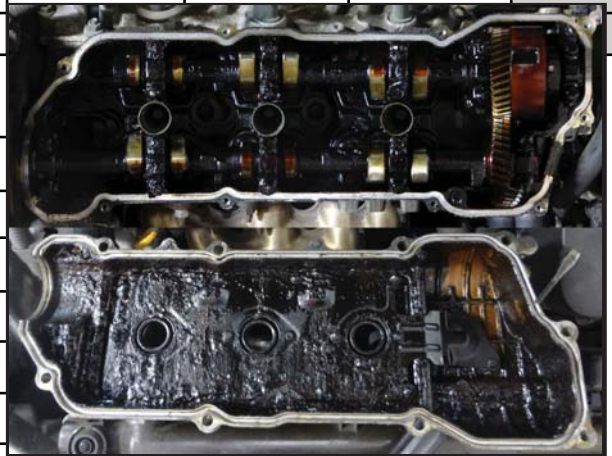
**Toyota's infamous sludge problem.**

The owner had had good luck with two similarly old Avalons in the past. He bought this one for this son and was surprised to find that it not only smoked on start-up (unless parked uphill), but the engine was using a ton of oil, especially on the highway - in that first sample the engine blew through 14 quarts in 3,000 miles. So the first sample's metals were severely diluted. (All that make-up oil is also the reason the TBN read so high.) He suspected the problem was the valve guides, but when he looked at the spark plugs, #2 was clearly worse than the others, with ash deposits bridging the plug gap. However, the plug was iridium and was still able to fire under the terrible conditions. It only generated an error code under hard highway acceleration. According to the owner's research, cylinder #2 is the sludge canary in the coal mine for this type of Toyota. The rear valve cover was so sludged up that sludge was preventing internal engine air from getting to the PCV valve. The pressure was forcing oil out every place it could, mostly through the valve stem seal. Replacing the valve cover fixed the oil consumption problem. So why is wear so high in the second sample? It turns out that fixing the first problem may have uncovered a second issue. Lead and tin typically indicate bearing wear; those metals were being masked by the excessive oil being added in the first sample. Silicon is from sealers used in the fix.
