Everyone's favorite part of the newsletter is the Report of the Month, so we thought this month we'd give you what you really want to see -- aircraft problems that you don't have to deal with! What follows are four aircraft samples, each with some sort of problem. We have reported what the owner or mechanic told us in the comments below each report. But before you look at the answer, take a minute to study the data. Can you figure out what went wrong?

### Report of the Month

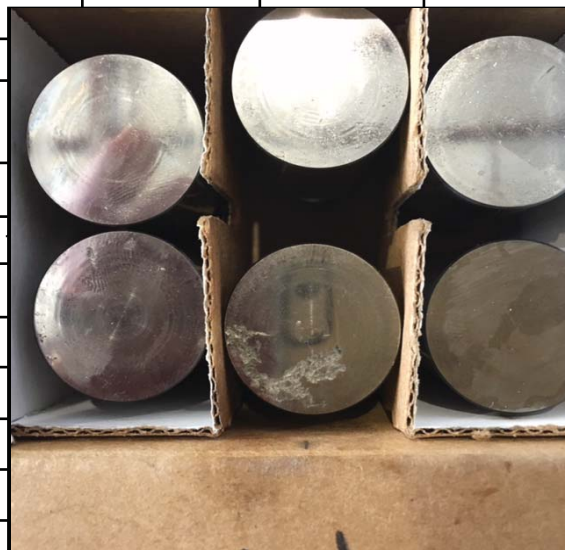
The change in wear is what alerted us to trouble in this IO-550-N. What's the problem?

The mechanic says that when he saw the change in wear, he had the customer bring the engine in right away. "We checked compression, borescope-inspected the cylinders, removed the rocker covers, and inspected the rocker shafts, bushings, and valves. Removed some sample lifters and found the problem. The lifters were just starting to spall and flake. The cam was okay, but I'm sure the iron getting into the oil was causing other metals to wear. We will keep an eye on the next two samples."
