Report of the Month

Motorcycles have problems too, and this Yamaha YZF-R6 engine isn't wearing all that well. Can you tell where the problem is?

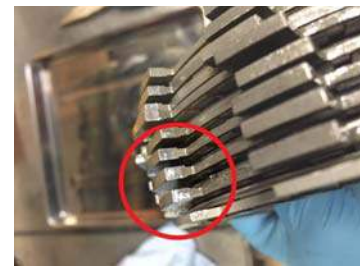
Note the wear on the clutch discs. The owner suspects the discs were wearing on the clutch housing (below), causing the high aluminum.

When the owner of this bike got our report, it prompted him to cut open the filter, which contained visible aluminum flakes. As you may know, any metal that you can actually see is metal that's too large for our spectrometer to read. When he saw the metal, the owner suspected something was going on so he pulled the clutch. It revealed substantial wear on the clutch housing and friction plates - see the pictures above. He suspects this is where the metal came from. He said he races the bike with very hard downshifting into corners. This is, according to the owner, the likely cause for the excess wear.
