## Report of the Month

Motorcycles have problems too, and this Yamaha YZF-R6 engine isn't wearing all that well. Can you tell where the problem is?

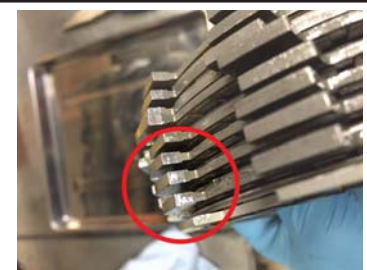
Note the wear on the clutch discs. The owner suspects the discs were wearing on the clutch housing (below), causing the high aluminum.

When the owner of this bike got our report, it prompted him to cut open the filter, which contained visible aluminum flakes. As you may know, any metal that you can actually see is metal that's too large for our spectrometer to read. When he saw the metal, the owner suspected something was going on so he pulled the clutch. It revealed substantial wear on the clutch housing and friction plates - see the pictures above. He suspects this is where the metal came from. He said he races the bike with very hard downshifting into corners. This is, according to the owner, the likely cause for the excess wear.
