Everyone's favorite part of the newsletter is the Report of the Month, so we thought this month we'd give you what you really want to see -- interesting engines and problems that you don't have to deal with! We'll start with this completely stock '49 Ford running Mobil 1 10W/30 Extended Performance oil, driven by the owner cross-country. He was sampling just to see how bad the engine beat up the oil. The car did not use enough oil to have to add any. It's a non-PCV motor running a stock carb that got hot going through the mountains. See the owner's comments below.

### Report of the Month

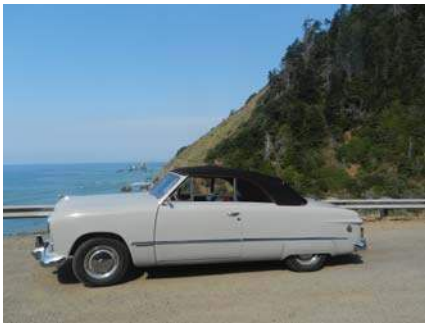
| ELEMENTS IN PARTS PER MILLION | MI/HR on Oil | 8,100 | UNIT/<br>LOCATION<br>AVERAGES | | | UNIVERSAL<br>AVERAGES |
|---|---|---|---|---|---|---|
| Values<br>Should Be* | | | | <p>From the owner: In September 2017 I embarked on a trip across The Great Northern Route Two to the Western National Meet of the early Ford V8 Club of America in Salem, Oregon. The route goes from Bar Harbor, Maine to Everett, Washington. Other than a couple of cities it is basically rural -- there may be speed limit signs, but not much else.</p> <p>Along the way I stopped at the head of the Mississippi River as well as Glacier National Park. Upon arriving in Washington I had to have tires put on the car, but other than that no breakdowns. After the meet I proceeded south and took tour of the redwoods and across the Golden Gate Bridge. Route 1 in northern California was one of the curviest hilly roads I ever drove. It was probably my lowest average speed for the whole trip.</p> <p>From San Mateo I proceeded east through Yosemite National Park and into Nevada. I hit my high point at the Vail Pass at 10,666 feet, and while the car was anemic and vapor-locking a bit as well as overheating, I made it to the top. I cooled on the downhill but still needed a fair amount of water. The rest of the trip was problem-free! Total fuel cost was \$1230 for 431 gallons of fuel. Average mpg for trip was 18.8. The engine is bone stock and I run a GPS off the 6-volt positive ground by floating a power point with the correct DC orientation. All mileage numbers and driving times came from the GPS. Here is a link to my Facebook page:</p> <p><a href="https://www.facebook.com/groups/134503040494452/">https://www.facebook.com/groups/134503040494452/</a></p> | | |
