Report of the Month

The IO-360 engine in this Piper Arrow had a problem.
Can you tell what it was?

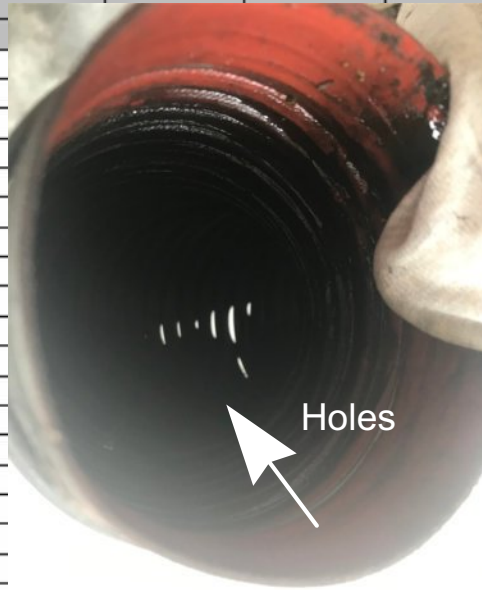
The first sample was the owner's initial analysis after he bought the airplane. That sample indicated high silicon. he changed the air filter element and found some leaks in the filter housing, repairing everything he could find. That helped. But when he did the second sample, silicon had improved, but it was still elevated. And we were still seeing metal. At that point the owner pulled the SCEET air duct off. It's not easy to see in the picture, but the duct had many holes in the walls. That should take care of the lingering dirt contamination issues, and help improve wear quite a bit.
