The Lower Unit Blues

by Ryan Stark

The Boat & its Lower Unit

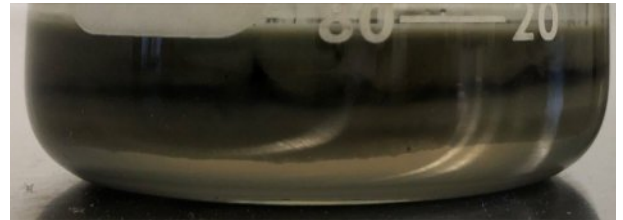
Figure 1: Not good.

20+ years to know what serious water contamination looks like. Think milkshake, with the main color being whatever the color of the oil was to start with. When an oil with red dye gets water in it, it tends to look like strawberry milkshake. If the oil starts out blue, you end up with a blueberry milkshake. Start with brown oil and you get chocolate.

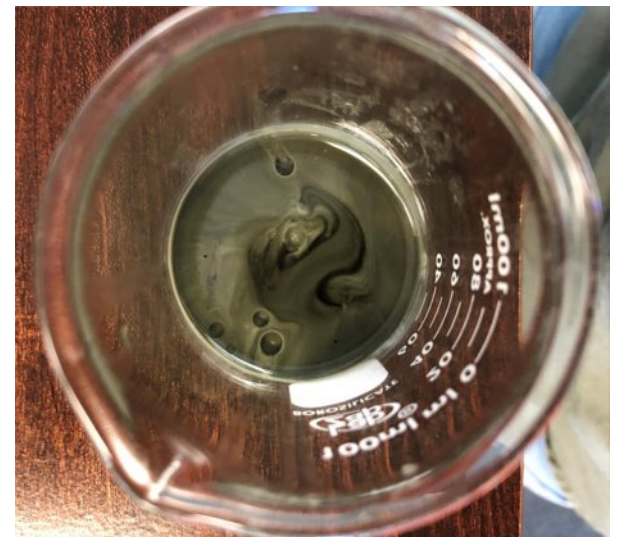
Figure 2: Not good at all.

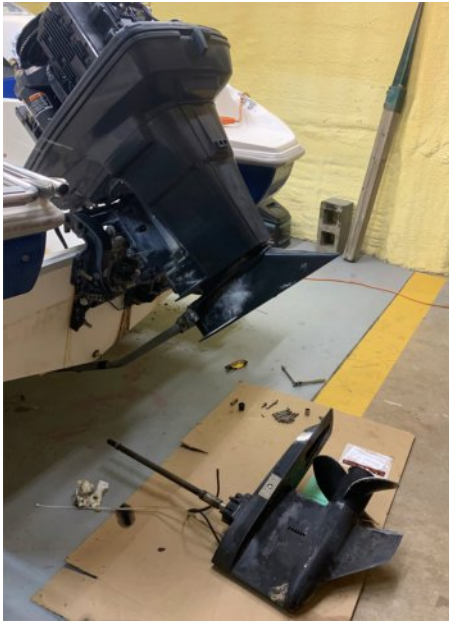
Figure 3: The lower unit, separated.

So this year, when I went to try to put it in the lake I got quite the surprise when I found it the motor would not shift out of forward. Of course, I didn't know this until I was trying to back the boat away from the boat trailer at the ramp. Needless to say, I was very confused as to why the boat was going forward when I had it in reverse, and Kathy was even more confused (and profane) when she thought the boat was going to end up in the bed of her truck. I did start the engine prior to heading to the lake and it was running like a champ. I just didn't think to check to see if the motor would go into reverse, or even shift at all. Live and learn.

So now the lower unit is in a partial state of disassembly in my garage, and let me tell you — nothing is a sadder sight in the middle of boating season. I find myself struggling with shame and regret about not having changed oil in it sooner, or better yet, just fixed the seal that was letting water in in the first place. My only hope is that you don't let the same thing happen to you. Change that lower unit oil and sleep easy at night. Meanwhile, I'll be learning the *real* meaning of the word boat - **Bust Out Another Thousand!**

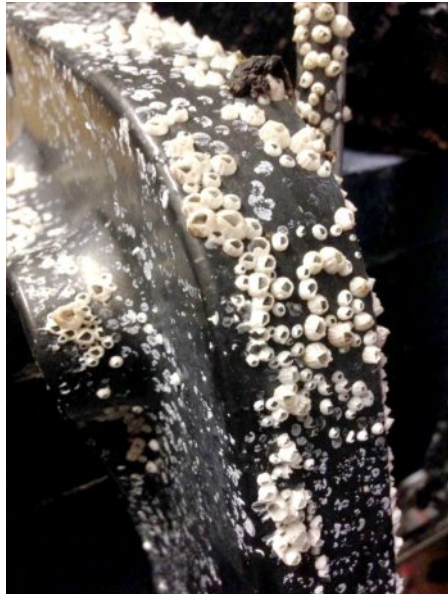
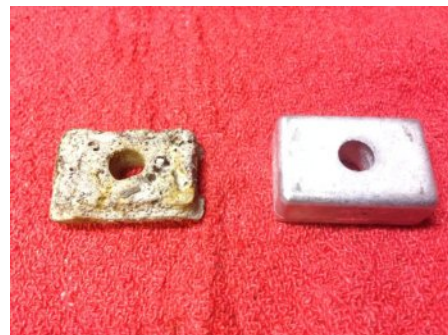
**Top: Barnacles galore.
Bottom: Old zinc plate vs new.**

This engine sat flooded, covered in barnacles, underwater on the bottom of a southern California boat launch for about a year. Here's the story: "I originally found the sunk motor on Craigslist for sale by the marine biologist who recovered it. Judging by the size of some of the barnacles on the motor, I'm guessing it was underwater for up to a year - possibly longer. The clamps were stuck in a wide-open position so I think someone forgot to tighten them before they launched and the motor fell off the boat and sunk.

My plan was to use this as a parts motor for my Tohatsu 5 hp LS. When I bought the engine, it was covered in barnacles with sea water and grit sloshing around in the gear case. It was advertised as not seized, but it very much was. The prop spun in neutral, but that's about it. The condition of the outside of the motor was quite good. The zinc at the bottom of the drive leg was nearly completely dissolved and looked like Swiss cheese. But it had done a good job of protecting the motor. (Story continues on next report.)

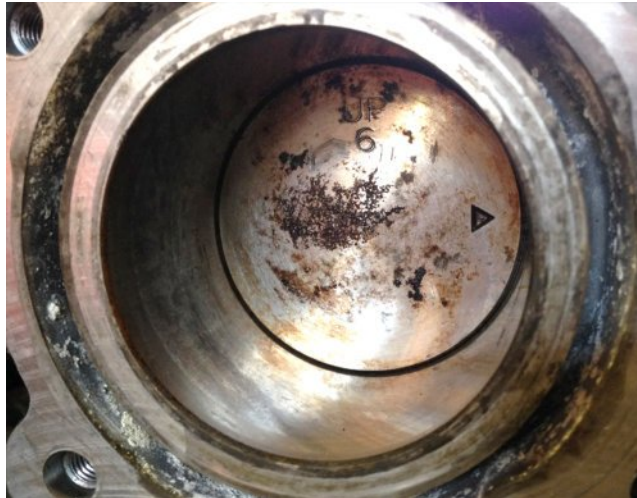
Be glad your cylinders don't look like this.

Story continues: I flushed out the power head with kerosene and scrubbed all the grit I could reach out of the valve train. I soaked the cylinder in a mix of SeaFoam and penetrating oil overnight. In the morning I was able to break the cylinder free by gently rocking the flywheel back and forth. After freeing the piston I flushed out the kerosene and put in fresh motor oil. Once the motor was moving freely I decided to put a spark plug onto the boot to see if the ignition system had survived being soaked in seawater for so long. And much to my surprise, it started making spark! The carburetor was in poor shape. It likely had ethanol gas in it when it went under and it had reacted with the salt water to nearly completely fill the interior of the carb and fuel system with a thick, white crystalline deposit. So I swapped on a spare 5 hp carb from my other Tohatsu and plugged a fuel tank directly into the replacement carburetor. I set everything up outside in a barrel full of water. And after maybe 10 pulls and much coughing and sputtering, the motor started and ran! At that point I hadn't replaced any parts except the temporary carburetor.

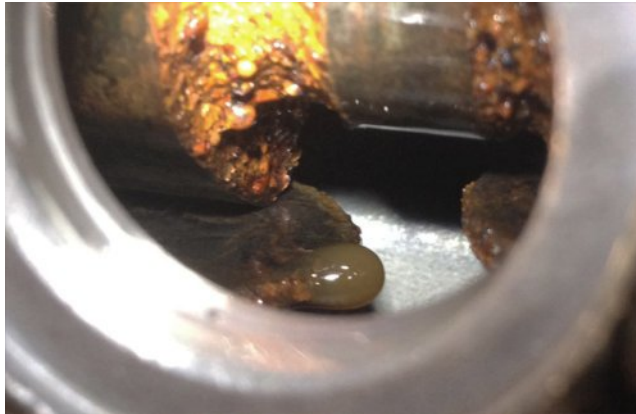
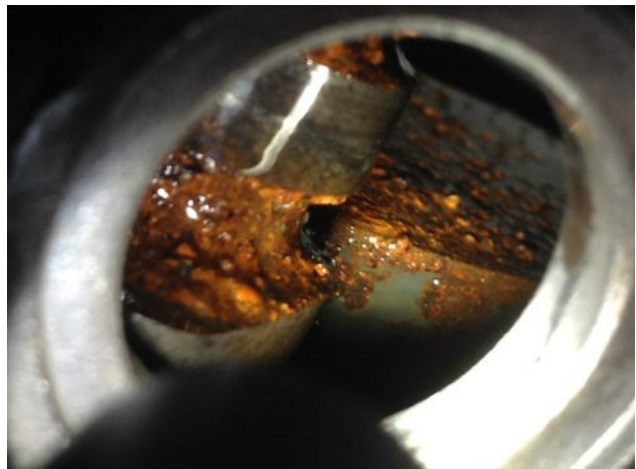
Both images are from the fuel ports. Not pretty.
