Report of the Month

If you look at the pictures, it's not too much of a mystery what happened to this 2001 Tohatsu 4-stroke engine. But take a guess anyway!

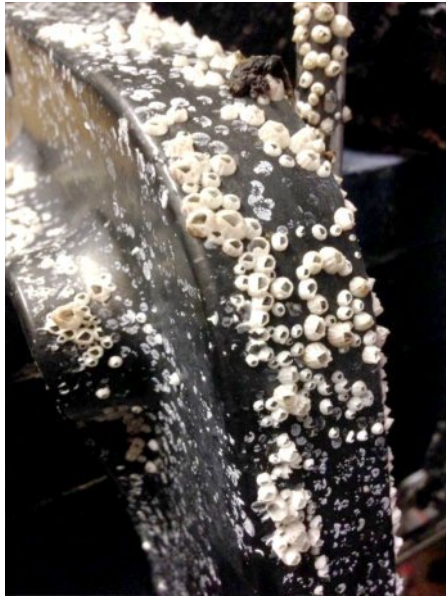
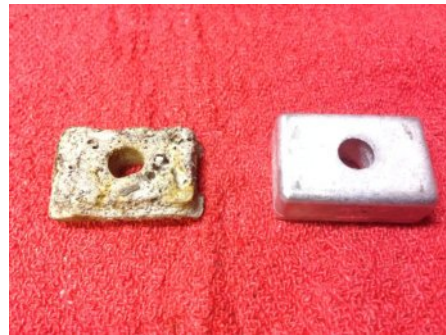
**Top: Barnacles galore.
Bottom: Old zinc plate vs new.**

This engine sat flooded, covered in barnacles, underwater on the bottom of a southern California boat launch for about a year. Here's the story: "I originally found the sunk motor on Craigslist for sale by the marine biologist who recovered it. Judging by the size of some of the barnacles on the motor, I'm guessing it was underwater for up to a year - possibly longer. The clamps were stuck in a wide-open position so I think someone forgot to tighten them before they launched and the motor fell off the boat and sunk.

My plan was to use this as a parts motor for my Tohatsu 5 hp LS. When I bought the engine, it was covered in barnacles with sea water and grit sloshing around in the gear case. It was advertised as not seized, but it very much was. The prop spun in neutral, but that's about it. The condition of the outside of the motor was quite good. The zinc at the bottom of the drive leg was nearly completely dissolved and looked like Swiss cheese. But it had done a good job of protecting the motor. (Story continues on next report.)

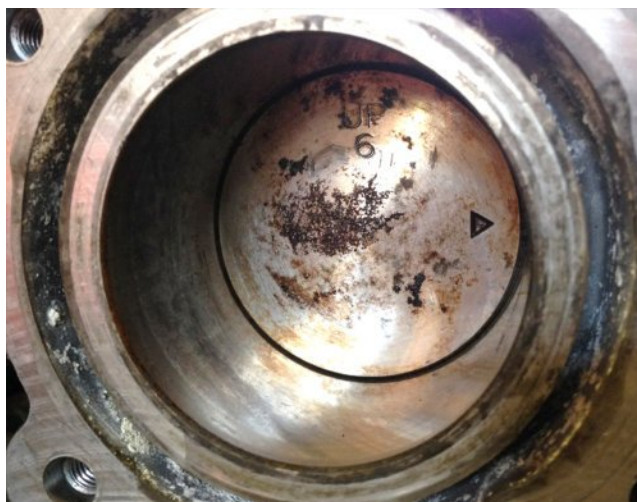
Be glad your cylinders don't look like this.

The above sample was taken after repairing the broken valve spring (see the next part of the story). Doesn't look great, but most of the metal is from the wear-in process. Sodium has improved a lot.

Story continues: I flushed out the power head with kerosene and scrubbed all the grit I could reach out of the valve train. I soaked the cylinder in a mix of SeaFoam and penetrating oil overnight. In the morning I was able to break the cylinder free by gently rocking the flywheel back and forth. After freeing the piston I flushed out the kerosene and put in fresh motor oil. Once the motor was moving freely I decided to put a spark plug onto the boot to see if the ignition system had survived being soaked in seawater for so long. And much to my surprise, it started making spark! The carburetor was in poor shape. It likely had ethanol gas in it when it went under and it had reacted with the salt water to nearly completely fill the interior of the carb and fuel system with a thick, white crystalline deposit. So I swapped on a spare 5 hp carb from my other Tohatsu and plugged a fuel tank directly into the replacement carburetor. I set everything up outside in a barrel full of water. And after maybe 10 pulls and much coughing and sputtering, the motor started and ran! At that point I hadn't replaced any parts except the temporary carburetor.

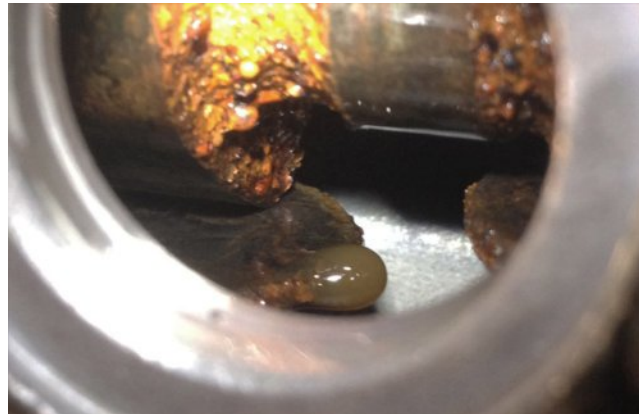
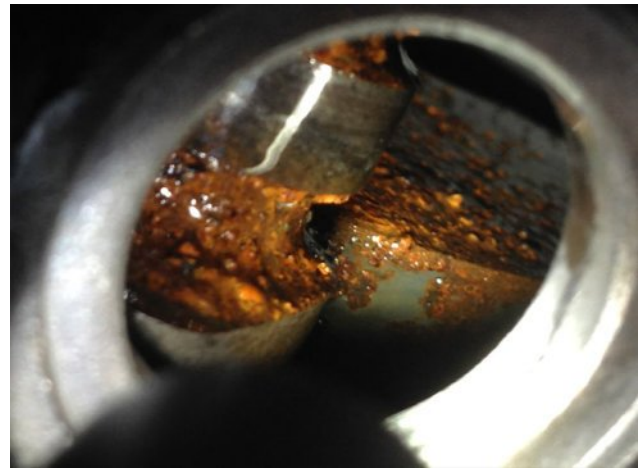
Both images are from the fuel ports. Not pretty.
