This IO-320 has a problem. Can you tell what it is?

UNIT	MAKE/MODEL: Lycoming IO-320-E2A	OIL TYPE & GRADE: Aircraft Engine Oil
	FUEL TYPE: Gasoline (Leaded)	OIL USE INTERVAL: 5 Hours
	ADDITIONAL INFO: Piper PA18-160, Chrome Cyls

This O-300 has a problem. Can you tell what it is?

UNIT	MAKE/MODEL: Continental O-300-A	OIL TYPE & GRADE: Phillips XC (A/C) 20W/50
	FUEL TYPE: Gasoline (Leaded)	OIL USE INTERVAL: 31 Hours
	ADDITIONAL INFO: Cessna 172, Mixed Cyl

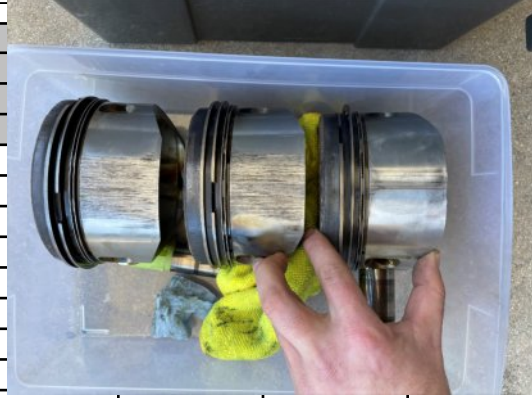
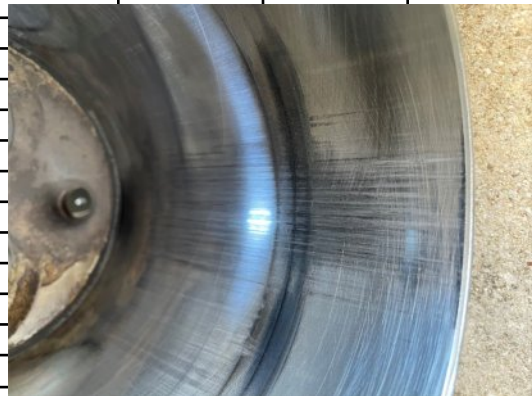
The owner knew something was obviously up when he got that first sample. In addition to metal in the oil report, the engine was seeing consistently high oil temps in cruise (210-230°F), and high CHT temps in #1 & #3 cylinders, as well as slightly rough running/vibrations in cruise & climb. Additionally, he reported, the engine felt very underpowered. "My engine is supposed to be rated at 160HP, but we had quite a difficult time getting off the water with two passengers, and one instructor who flew it said it felt like it had about as much power as his 100HP super cub. (His plane however is not on floats.)"

I suspected the high oil temps might be from a poorly designed/located oil cooler, but several mechanics said that's likely not enough to cause the consistent high temps I was getting, especially since we had the issue when flying in colder temperatures. Since I bought the aircraft used and didn't know the complete history on it, and since the engine only had ~225 hours on it in the 20 years since the major overhaul was done, I decided that I'd play it safe and pull all the cylinders after getting your oil analysis results of the extremely high chrome content, twice in a row.

The company who is inspecting and fixing/replacing my cylinders called me yesterday saying the following was wrong with my cylinders: the wrong piston rings were installed for chrome cylinders; heavy wear in every cylinder- scratches/gouges in #1 & #3 which tells him the plane likely sat for over a year in between startups; evidence of blow by in #1 & #3 - those cylinders also had small cracks developing; and several valves installed backwards (intake installed on exhaust side, & vice versa). He said this isn't a huge issue, but shows the laziness or inattention to detail by the mechanic who installed them (aka a warning sign that they did other things wrong, like use the completely wrong piston rings). So I'm having to get 2 new (reman'd) cylinders to replace the ones with cracks. And then he's overhauling everything else."

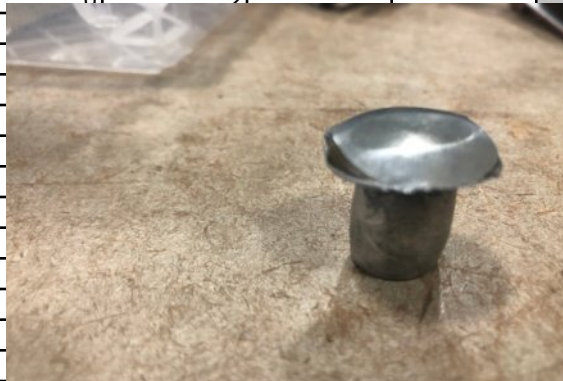
CLIENT	The owner says: In reference to the oil analysis surprise of a week and a half ago and the loaded oil filter media, we found the source of the aluminum flakes - worn piston pin plugs. This single plug was from cylinder # 4 and two more were worn on cylinder # 2. Also, we think the (front) thrust bearing is worn beyond limits, allowing the crankshaft to move too much. Looks like a major overhaul is coming.
--------	--

COMMENTS	Thanks for noting the stuck exhaust valve. Aluminum is really high - high enough to show a problem. If temps got high in the cylinder with the stuck exhaust valve, aluminum could be the result. We are also seeing copper, which in this engine is often from piston pin plugs, connecting rod piston pin bushings, or wrist pin problems. With iron, copper can be from the starter adaptor. Maybe all this will improve now that you've freed the valve, but check for problems anyway. Borescope the cylinders and check compressions. Watch for metal.
----------	--
