Pre-Ignition & Detonation

Pre-ignition. Detonation. Both can be deadly. But what's the difference? And how can you avoid them?

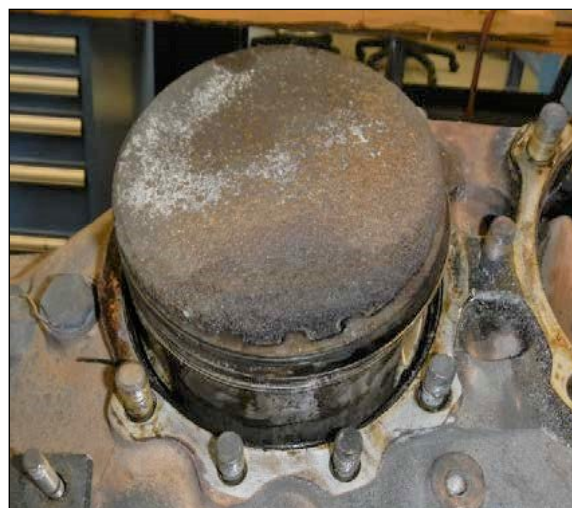
This engine is from a Beech S35 Bonanza's fatal accident. The #6 piston was eroded and began to melt. The rings and piston skirt were compromised by thermal expansion and metal transfer. Note the deep pitting and erosion of the piston face. This caused combustion gases to bleed into and over-pressurized the crankcase, forcing engine oil out the breather. The connecting rods then failed due to the lack of lubrication and smashed holes in the crank case, causing loss of power and engine failure.

Piston pitting and erosion of the piston face

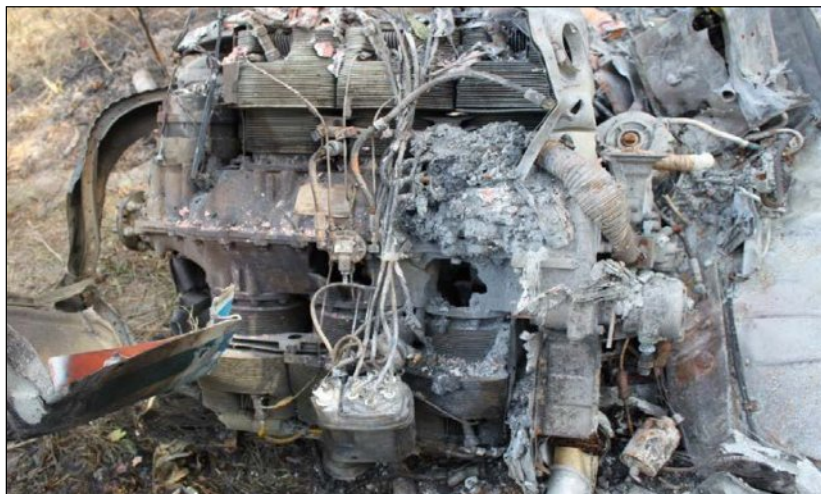
Bonanza end result

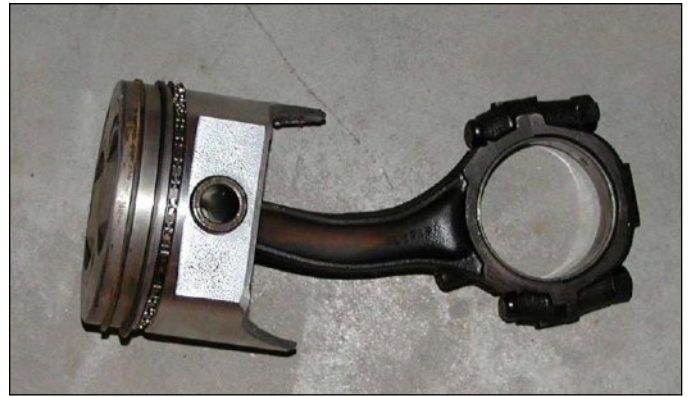
This bent connecting rod is from a car, but it's a good example of the damage pre-ignition and detonation can do.

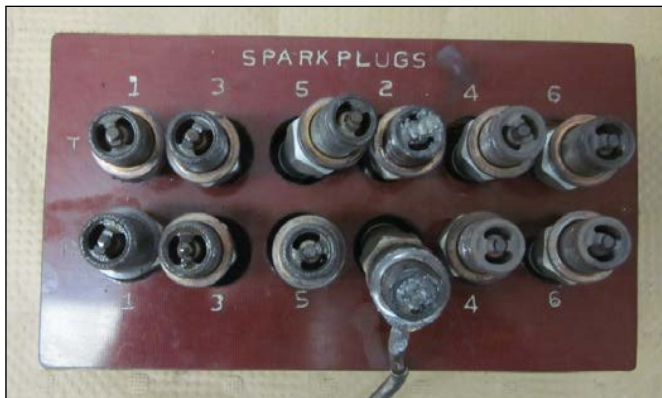
These cylinder #2 spark plugs are packed with melted piston material.

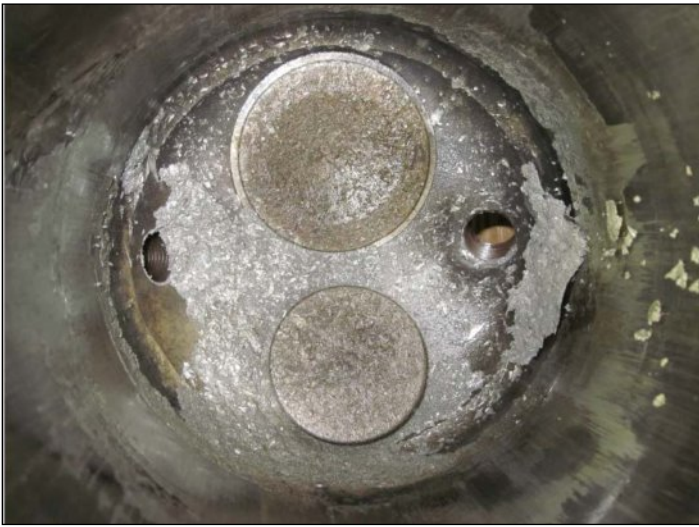
The picture to the left above is a cylinder head showing signs of pre-ignition or detonation. The carbon coating that normally lines the head dome is knocked off. There is melted piston material in the head and the cylinder sleeve is scored by the overheated piston.

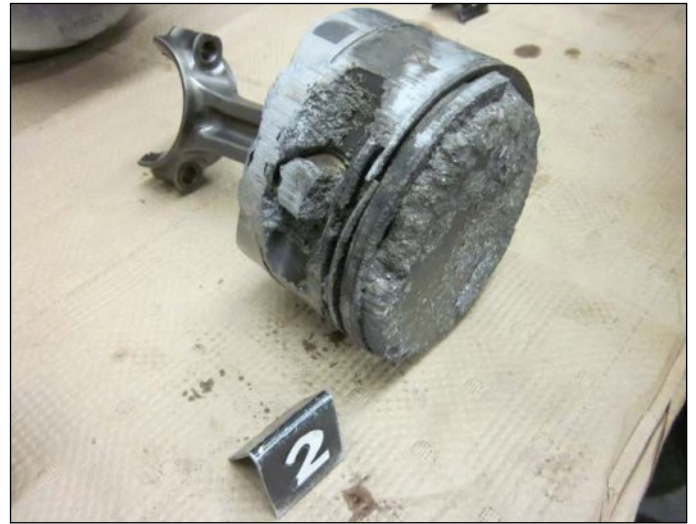
Above and to the right is the same piston. Note that the piston deck is eroded. The rings are broken. The piston skirt is scuffed from rubbing on the cylinder wall. A piston in this condition allows combustion gases into the crank case. This over-pressurizes the crankcase and blows engine oil out of the crank case breather -- all of the engine oil, in minutes.

Soon after the engine oil departs the connecting rods try to make a break for it, resulting in giant holes in the crank case - see the image to the right.

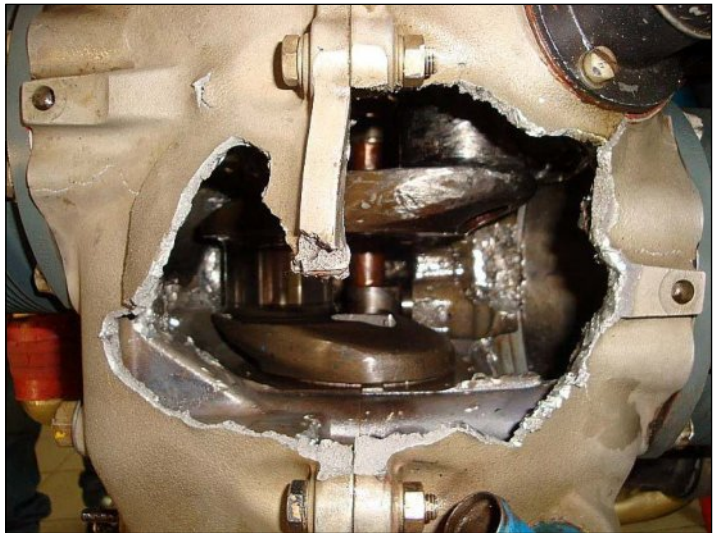
Classic signs of trouble

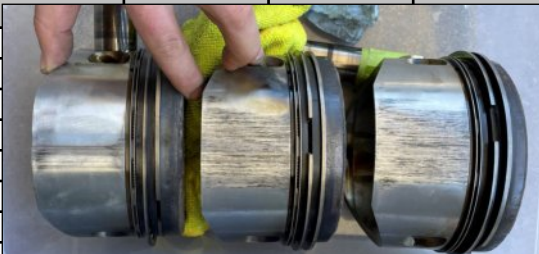
| ELEMENTS IN PARTS PER MILLION | MI/HR on Oil | 5 | UNIT / LOCATION AVERAGES | 30 | | | | | UNIVERSAL AVERAGES |
|---|---|---|---|---|--|--|--|--|---|
| | IRON | 43 | 129 | 129 | Note the sides of the pistons. You don't want yours to look like that. | | | | 35 |

- the wrong piston rings were installed for chrome cylinders
- heavy wear in every cylinder
- scratches/gouges in #1 & #3 which tells him the plane likely sat for over a year in between startups
- evidence of blow by in #1 & #3
- small cracks in the cylinders
- several valves installed backwards (intake installed on exhaust side, & vice versa). He said this isn't a huge issue, but shows the laziness or inattention to detail by the mechanic who installed them (aka a warning sign that they did other things wrong, like use the completely wrong piston rings)

I'm getting two new (reman'd) cylinders to replace the ones with cracks. And overhauling everything else.
