This 1995 Land Cruiser has a problem. What is it?
 To learn where the elements are coming from, [click here](#) and scroll down.

UNIT	MAKE/MODEL: Toyota 4.5L 6-cyl (1FZ-FE)	OIL TYPE & GRADE: Gasoline Engine Oil
	FUEL TYPE: Gasoline (Unleaded)	OIL USE INTERVAL: 1,500 Miles
	ADDITIONAL INFO:

This 2016 Subaru BRZ has a problem. What is it?
To learn where the elements are coming from,
[click here](#) and scroll down.

UNIT	MAKE/MODEL: Subaru 2.0L (FA20/4UGSE) 4-cyl	OIL TYPE & GRADE: Motul 300V 0W/20
	FUEL TYPE: Gasoline (Unleaded)	OIL USE INTERVAL: 250 Miles
	ADDITIONAL INFO:

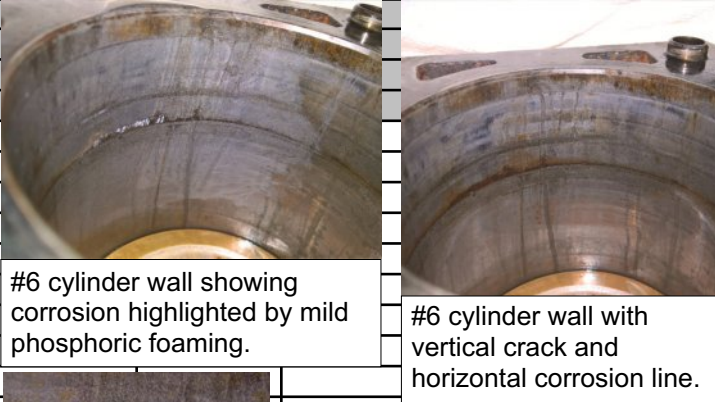
UNIVERSAL AVERAGES
	MI/HR on Unit	195,400				
	Sample Date	9/9/2020				
	Make Up Oil Added	7.5 qts				
ALUMINIUM	31	2			2	
CHROMIUM	1	0			0	
IRON	441	5			6	
COPPER	8	1			2	
LEAD	13	5	#6 cylinder wall showing corrosion highlighted by mild phosphoric foaming.		2	
TIN	2	0		#6 cylinder wall with vertical crack and horizontal corrosion line.	0	
MOLYBDENUM	44	114			65	
NICKEL	1	0			0	
MANGANESE	2	0			1	
SILVER	0	0			0	
TITANIUM	4	0			1	
POTASSIUM	0	2			4	
BORON	62	112			63	
SILICON	19	21			12	
SODIUM	81	20			34	
CALCIUM	1634	1959			1847	
MAGNESIUM	242	281			300	
PHOSPHORUS	1438	788			798	
ZINC	1201	938			943	
BARIUM	0	0	Crack highlighted with marker	Oil cooler full of flaking block sealer.	0

The owner writes: This engine started to overheat just 1500 miles after I bought it. I eventually got around to pulling the head, assuming I might have a leaking head gasket, and got a surprise. Cylinders #1-5 were in very good shape, smooth walls. Then I got to #6 and saw some staining. Closer inspection showed a *horizontal* line of corrosion and pitting, which indicates water had been sitting in that cylinder at some time in the past, before I purchased this vehicle. I also found, with my finger, a slight irregular *vertical* line, crack, or ridge on the rear wall of that cylinder going into the water jacket. To the eye it appeared just as a stain, but the finger swipe told the story.

So at some point before I got this vehicle the engine likely either hydrolocked and/or overheated and the cylinder wall cracked. Then the previous owner, undisclosed at the time of sale, had dumped in a few bottles of block sealer, then sold the vehicle to me. Also, when I took the cooling system apart, I found block sealer coating the inside of all components, everything coated in that sodium silicate stuff. So the previous owner knew he had a problem and dumped in the sealer, then sold the vehicle.

The cause of the elevated iron and couple other metals was likely from corrosion and a crack in a cylinder wall, and maybe some other minor damage causing other metals to go up a bit. The slightly elevated sodium could be explained by the sodium silicate block sealer added by the previous owner. Now I'm trying to find another block, or maybe sleeve the bad cylinder, and rebuild this block. The photos show the horizontal line of corrosion in the cylinder wall (the whitish foam is weak phosphoric acid I put there to highlight the rust and damage). Another photo was with a marker trying to outline the crack. The photo of the side of the block is where an oil cooler plate would be. That plate is removed so you're looking where the oil cooler normally would sit bathed in coolant. In that one you can see the old block sealer flaking off the surfaces of the water jacket that the previous owner had dumped in the cooling system to try to seal the crack in the cylinder wall.

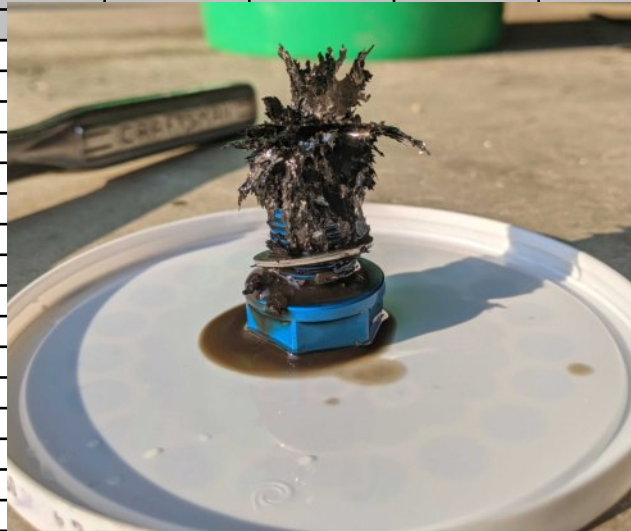
COMMENTS TIMOTHY: There's a lot of metal and silicon present, especially for just 250 miles. Race engines do tend to wear more than their street-only counterparts, but we're not sure that's the only reason why metals are so much higher than universal averages (based on ~5K miles). Parts like pistons/bearings (aluminum), steel shafts and cylinder liners (iron), and brass/bronze bushings (copper) might not be wearing well. Silicon might be partly to blame if it shows dirt, so check air filtration. Recent repairs could be another more harmless explanation. A trace of fuel is usually fine.

A fuzzy oil plug is never a happy find.

The owner writes: About 120 stage miles (so a good chunk of them with the engine at redline) after this report, the engine blew up. You'd correctly called out the high metal content, and a spun bearing on cylinder four finally came apart completely. Attached is a photo of the oil plug. We debated sending what drained out of the pan in for analysis, but decided that we weren't really hunting for trace amounts at that point.
