This '65 Mustang's got trouble.
Can you tell what's wrong?

UNIT	MAKE/MODEL: Ford 5.0L 302 CID V-8	OIL TYPE & GRADE: Motorcraft 10W/30
	FUEL TYPE: Gasoline (Unleaded)	OIL USE INTERVAL: 540 Miles
	ADDITIONAL INFO:

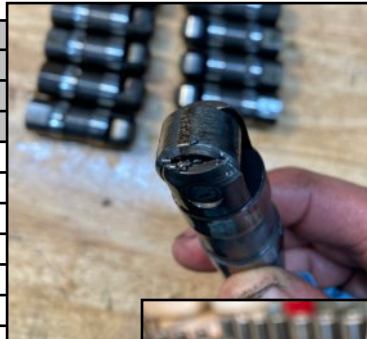
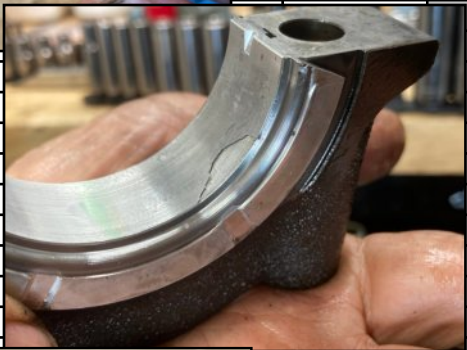
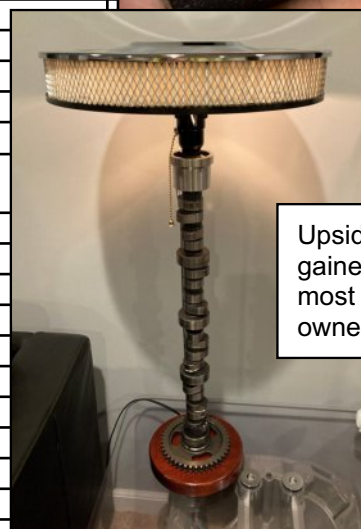
Upside: The wiped cam gained a new life as the most expensive lamp the owner ever hopes to own!

The owner reported back: "You nailed it when you suggested wear at a steel-on-steel interface like cams/lifters. I tore the engine down to find four hydraulic roller lifters failed, with damage to cam lobes. One lifter dogbone was found broken on cylinder #1's intake lifter, likely due to the lifter dropping lower into the block. The only other damage found was a chunk of bearing material missing from the #3 crank bearing. The big question is, why did the roller lifters stop rolling? I am going to take these bits to a local engine builder for further inspection and analysis.

Later, he reported: The engine builder inspected the valvetrain bits and believes the failure was due to an incorrectly set-up valve train. We found ALL of the pushrods were bent; some only very slightly. It is likely the pushrods were the incorrect length, or the rocker arm height was set incorrectly.
