Got Symptoms?

Get answers with Sacramento Sky Ranch!

Report of the Month

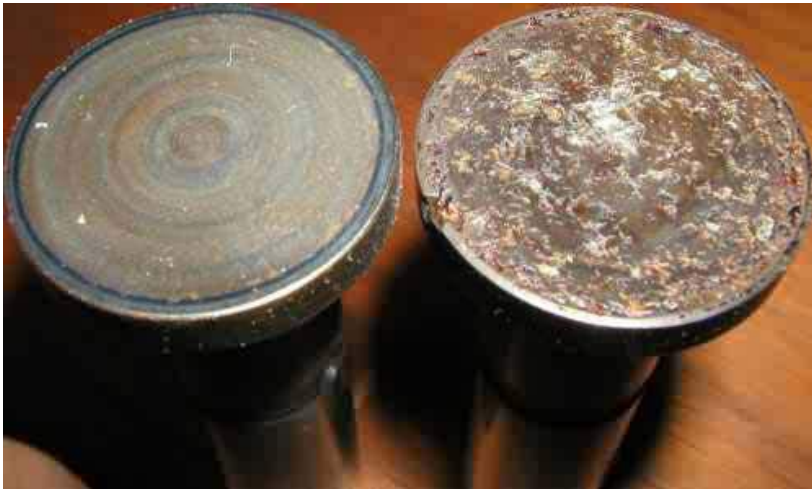
The follower on the left shows a normal circular wear pattern. The follower on right has chipped edges and gross deformities.

causing the edges to chip away. You can verify the misalignment by a careful examination of the wear marks on the lifter. Possible causes of this problem include:

When the bore wears and the follower is allowed to move from side to side, it causes small chips on the outside edges of the follower face. When you see these you would think that they occurred when the follower was dropped on the concrete floor and then installed into the engine. This is usually not the case. The misaligned follower allows the camshaft lobe to push down on the outside edge of the face,

1. A worn camshaft bore allows the camshaft to “walk” and therefore allows the camshaft lobe to press against outer edge of follower face. Loading at edge causes cracks and chips from face.
2. A worn follower bore, which allows the camshaft lobe to press against outer edge of follower face. Loading at edge causes cracks and chips from face (most probable).
3. Nicks on the side of the follower.

If the side of the follower is nicked, as might occur if they are all thrown into a tray during engine overhaul, then the nick creates a raised area on the side of the follower. This raised area creates the same effect as an out-of-round follower. The follower does not center in the bore and thus the camshaft lobe contacts the follower face at the edge.

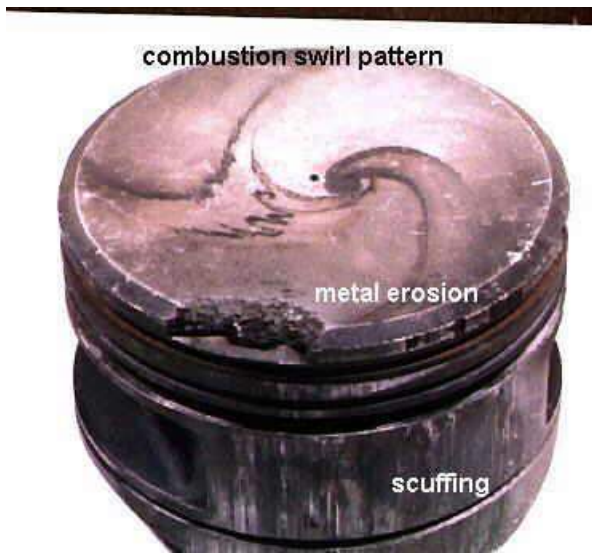
Swirl markings on the top of the piston are normal combustion pattern markings. Pre-ignition caused the erosion on this piston dome.

Premature ignition of fuel/air mixture in advance of normal ignition is usually caused by a hot spot in combustion chamber or magneto cross-fire. The hot spot is typically the spark plug electrode or exhaust valve. When pre-ignition occurs, ignition timing is lost and the upward movement of the piston is opposed by the high pressure generated by the early combustion. With pre-ignition, think “heat” and “meltdown.” Detonation, on the other hand, is synonymous with violence, explosiveness, and destruction.

1. Cracked spark plug ceramic from thermal shock.
2. Aluminum erosion on piston dome. In minor pre-ignition the erosion can appear as roughness of the piston dome or dome of the cylinder chamber. In major pre-ignition a

hole can be burned through the piston (usually at the outside edge and through the top ring land), or result in major erosion of cylinder chamber.

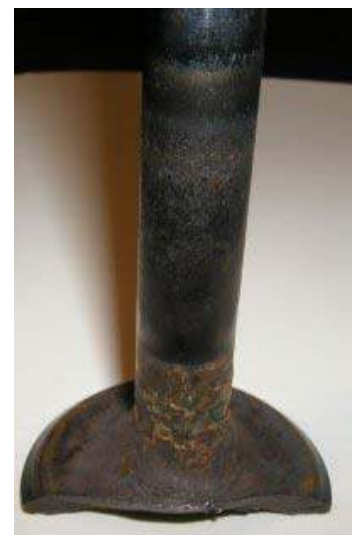
Figure 1

The image to the right (Figure 1) is an instance of valve face breakage caused by a valve overheating. Notice the dark color of the valve stem. This valve was abnormally hot from leakage past the valve face.

What causes valve breakage? The face of an exhaust valve is a ring. Exhaust gas leakage past the valve face heats one spot on the ring and expands it into an oval shape. This uneven ring expansion creates hoop stress. After a few cycles of uneven expansion and contraction, stress cracks form at the outside edge of the face. These cracks progress inward toward the center of the valve. When the cracks progress about ¼ of an inch, they turn 90 degrees and grow around the valve face. When two cracks come together, a piece of exhaust valve breaks off, the engine loses power, and the piece of broken valve damages the cylinder and most likely the turbocharger.

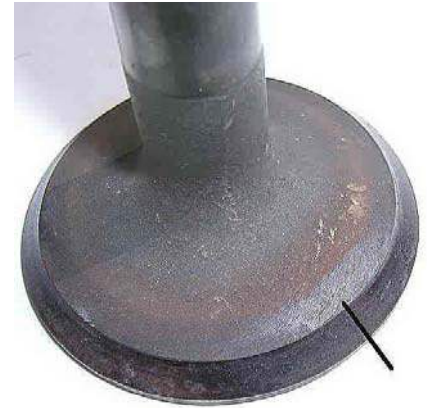
Valve leakage is much less visible when looking at the valve seat. Notice the uneven coloration.

What causes valve sticking? Exhaust gas leaving the cylinder flows past the valve face, causing heat loading to the valve. Most of the heat the valve absorbs conducts to the valve seat and from there to the cylinder and into the atmosphere. A leaking valve reduces the amount of heat conducted to the seat, causing the valve to over-heat. The hot valve causes oil to form carbon deposits on the valve stem, which sticks the valve in the guide.

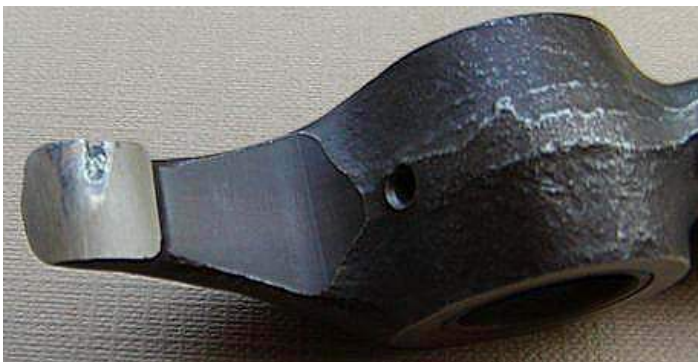
occurs when the rocker arm face rests flat against the valve tip.

The seat, guide, rocker arm, valve springs, and rocker bosses should center the valve stem in the guide. The valve stem then moves through the guide with a minimum of side force against the guide. Rapid wear results when the valve stem pushes against the guide. Proper valve alignment

This rocker arm shown in Figure 2 (previous page) wore the valve guides out in 350 hours. Note the contact on the edge of the face indicating that the face has been ground at a slight angle. This pushes the valve stem against the guide, resulting in rapid valve guide wear. A rocker arm face should have a cycloid curve. Anything less or more results in more movement of the rocker face across the valve stem.

You can check rocker arm alignment by making sure the rocker arm face sits flat on the valve stem. This should be done when the cylinder is installed. Such a check verifies alignment for the rocker shaft, rocker arm, rocker arm face, and valve guide. If any one of these is tilted, the rocker face will not rest flat on the valve stem.
