## Got Symptoms?

### Get answers with Sacramento Sky Ranch!

# Report of the Month

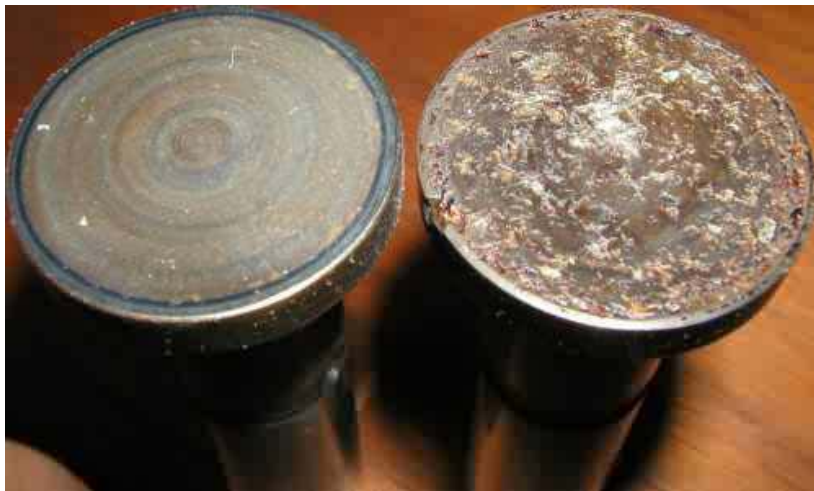
**The follower on the left shows a normal circular wear pattern. The follower on right has chipped edges and gross deformities.**

When the bore wears and the follower is allowed to move from side to side, it causes small chips on the outside edges of the follower face. When you see these you would think that they occurred when the follower was dropped on the concrete floor and then installed into the engine. This is usually not the case. The misaligned follower allows the camshaft lobe to push down on the outside edge of the face,

causing the edges to chip away. You can verify the misalignment by a careful examination of the wear marks on the lifter. Possible causes of this problem include:

1. A worn camshaft bore allows the camshaft to “walk” and therefore allows the camshaft lobe to press against outer edge of follower face. Loading at edge causes cracks and chips from face.
2. A worn follower bore, which allows the camshaft lobe to press against outer edge of follower face. Loading at edge causes cracks and chips from face (most probable).
3. Nicks on the side of the follower.

If the side of the follower is nicked, as might occur if they are all thrown into a tray during engine overhaul, then the nick creates a raised area on the side of the follower. This raised area creates the same effect as an out-of-round follower. The follower does not center in the bore and thus the camshaft lobe contacts the follower face at the edge.

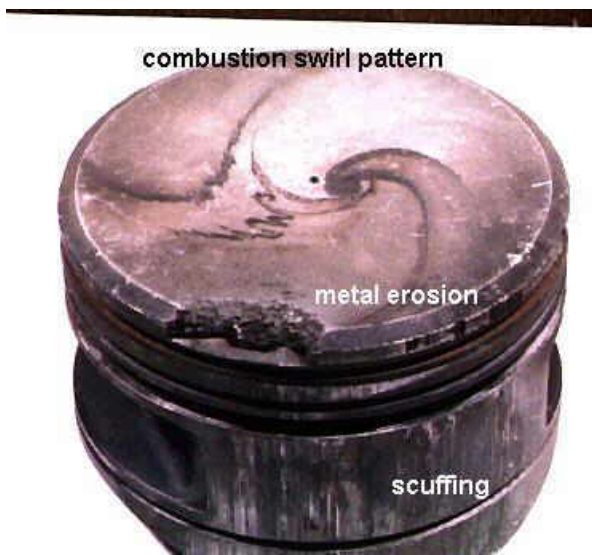
**Swirl markings on the top of the piston are normal combustion pattern markings. Pre-ignition caused the erosion on this piston dome.**

Premature ignition of fuel/air mixture in advance of normal ignition is usually caused by a hot spot in combustion chamber or magneto cross-fire. The hot spot is typically the spark plug electrode or exhaust valve. When pre-ignition occurs, ignition timing is lost and the upward movement of the piston is opposed by the high pressure generated by the early combustion. With pre-ignition, think “heat” and “meltdown.” Detonation, on the other hand, is synonymous with violence, explosiveness, and destruction.

1. Cracked spark plug ceramic from thermal shock.
2. Aluminum erosion on piston dome. In minor pre-ignition the erosion can appear as roughness of the piston dome or dome of the cylinder chamber. In major pre-ignition a

hole can be burned through the piston (usually at the outside edge and through the top ring land), or result in major erosion of cylinder chamber.

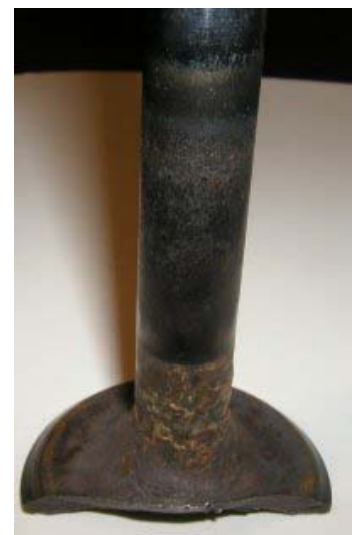
**Figure 1**

The image to the right (Figure 1) is an instance of valve face breakage caused by a valve overheating. Notice the dark color of the valve stem. This valve was abnormally hot from leakage past the valve face.

What causes valve breakage? The face of an exhaust valve is a ring. Exhaust gas leakage past the valve face heats one spot on the ring and expands it into an oval shape. This uneven ring expansion creates hoop stress. After a few cycles of uneven expansion and contraction, stress cracks form at the outside edge of the face. These cracks progress inward toward the center of the valve. When the cracks progress about ¼ of an inch, they turn 90 degrees and grow around the valve face. When two cracks come together, a piece of exhaust valve breaks off, the engine loses power, and the piece of broken valve damages the cylinder and most likely the turbocharger.

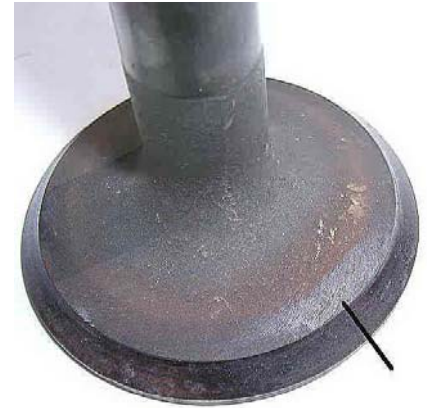
**Valve leakage is much less visible when looking at the valve seat. Notice the uneven coloration.**

What causes valve sticking? Exhaust gas leaving the cylinder flows past the valve face, causing heat loading to the valve. Most of the heat the valve absorbs conducts to the valve seat and from there to the cylinder and into the atmosphere. A leaking valve reduces the amount of heat conducted to the seat, causing the valve to over-heat. The hot valve causes oil to form carbon deposits on the valve stem, which sticks the valve in the guide.

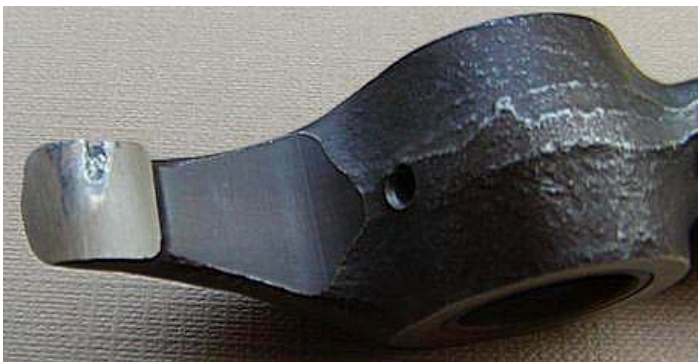
**Figure 2**

This rocker arm shown in Figure 2 (previous page) wore the valve guides out in 350 hours. Note the contact on the edge of the face indicating that the face has been ground at a slight angle. This pushes the valve stem against the guide, resulting in rapid valve guide wear. A rocker arm face should have a cycloid curve. Anything less or more results in more movement of the rocker face across the valve stem.

You can check rocker arm alignment by making sure the rocker arm face sits flat on the valve stem. This should be done when the cylinder is installed. Such a check verifies alignment for the rocker shaft, rocker arm, rocker arm face, and valve guide. If any one of these is tilted, the rocker face will not rest flat on the valve stem.
