# Inspecting Your Oil Filter

by Luke Miller, Senior Analyst

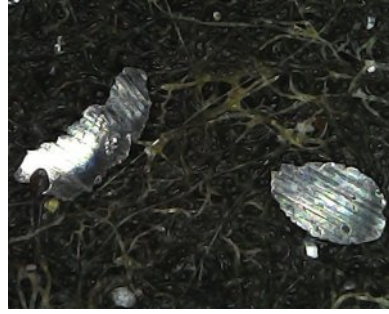
Close-up of aluminum flakes

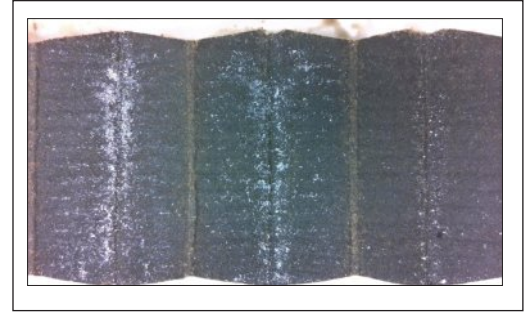
Severe aluminum particles in filter

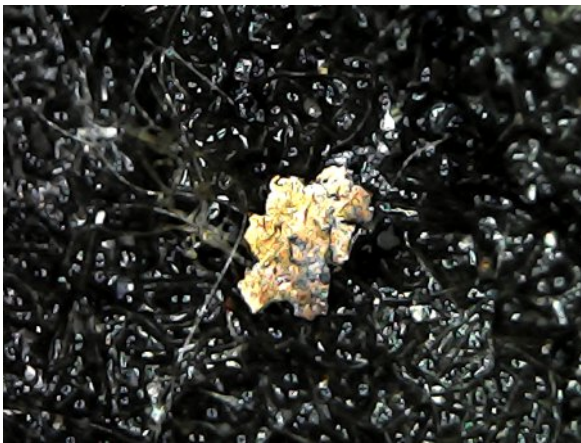
Copper-containing alloys, such as brass or bronze, vary from a light straw to copper color and will not react to a magnet.

Close-up of brass or bronze flake

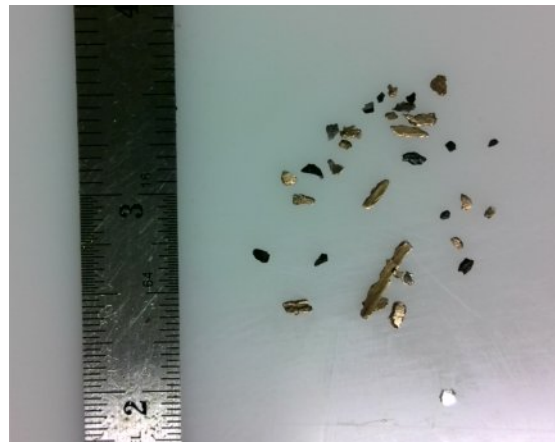
Mixture of brass/bronze particles and carbon

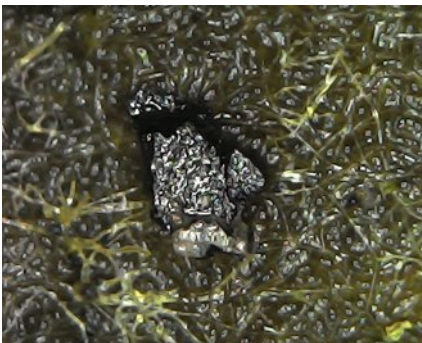
It is also common to find carbon, especially in the filters from turbocharged engines. Carbon looks like black, hard particles that can be broken apart between your fingers (see the pictures below). A large amount of carbon might indicate excess blow-by, but what counts as excessive is unique to each engine. Regularly checking the oil filter will give you a good idea of how much carbon is normal for your engine. You might find carbon with steel embedded in it, so it is good to check carbon particles with a magnet.

Close-up of carbon particle

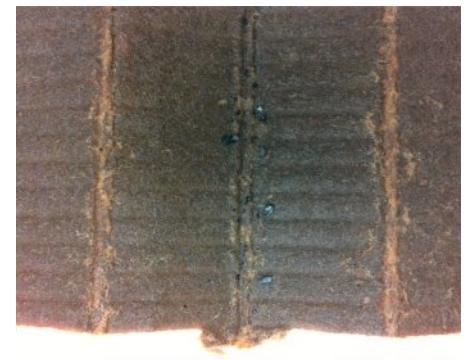
Carbon particles in filter pleat

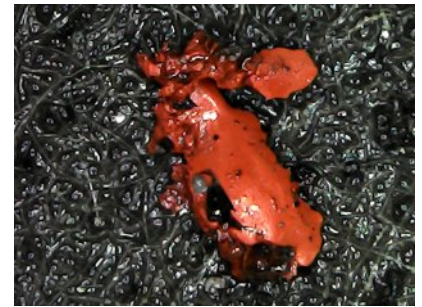
Small bits of sealer material may be found, especially after repairs. We generally don't worry about this sort of non-metallic debris.

Sealer material isn't typically worrisome

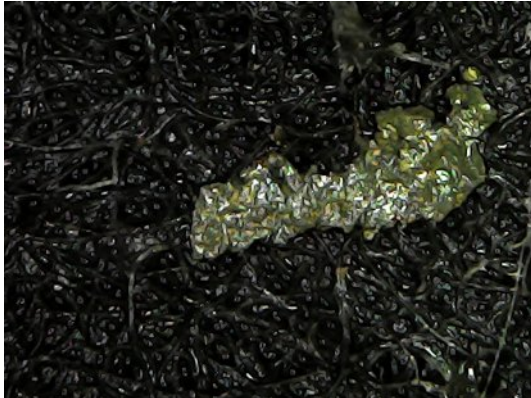
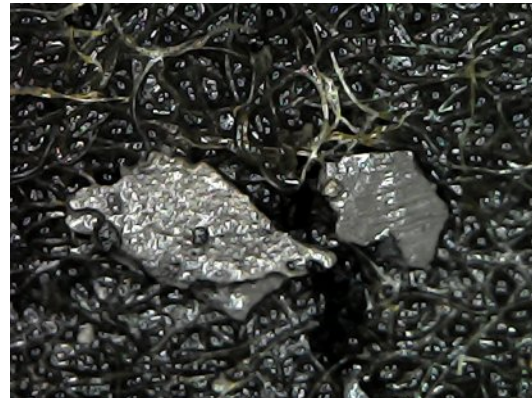
You might also find lead deposits from fuel blow-by. These particles have a bright, foil-like appearance that can look very much like a metallic wear particle. These deposits can be distinguished from metallic wear by their soft and "smudgy" texture. It is worth mentioning that these deposits are not lead from the wearing surface of a crank or camshaft bearing.

Both photos: lead deposits

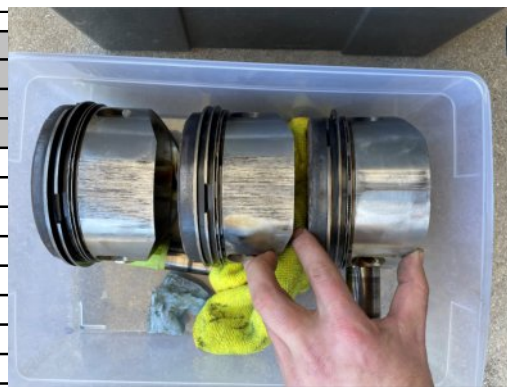
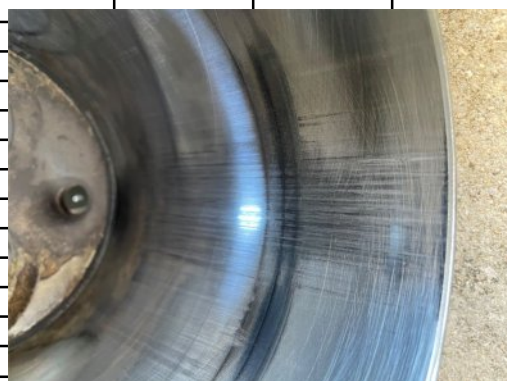
The owner knew something was obviously up when he got that first sample. In addition to metal in the oil report, the engine was seeing consistently high oil temps in cruise (210-230°F), and high CHT temps in #1 & #3 cylinders, as well as slightly rough running/vibrations in cruise & climb. Additionally, he reported, the engine felt very underpowered. "My engine is supposed to be rated at 160HP, but we had quite a difficult time getting off the water with two passengers, and one instructor who flew it said it felt like it had about as much power as his 100HP super cub. (His plane however is not on floats.)

The company who is inspecting and fixing/replacing my cylinders called me yesterday saying the following was wrong with my cylinders: the wrong piston rings were installed for chrome cylinders; heavy wear in every cylinder- scratches/gouges in #1 & #3 which tells him the plane likely sat for over a year in between startups; evidence of blow by in #1 & #3 - those cylinders also had small cracks developing; and several valves installed backwards (intake installed on exhaust side, & vice versa). He said this isn't a huge issue, but shows the laziness or inattention to detail by the mechanic who installed them (aka a warning sign that they did other things wrong, like use the completely wrong piston rings). So I'm having to get 2 new (reman'd) cylinders to replace the ones with cracks. And then he's overhauling everything else."
