Inspecting Your Oil Filter

by Luke Miller, Senior Analyst

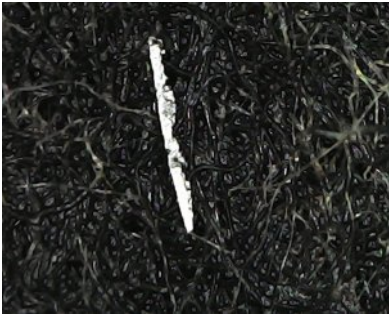
Aluminum has a bright, silver appearance and will not react to a magnet.

Close-up of an aluminum sliver

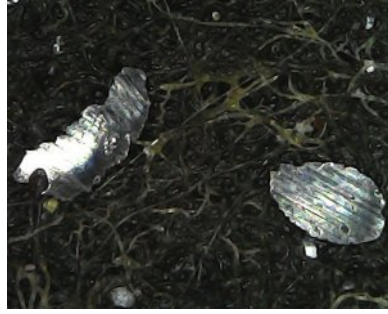
Close-up of aluminum flakes

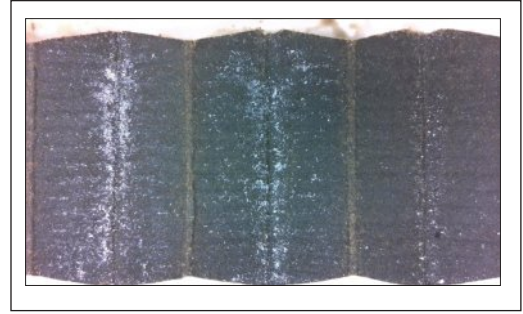
Severe aluminum particles in filter

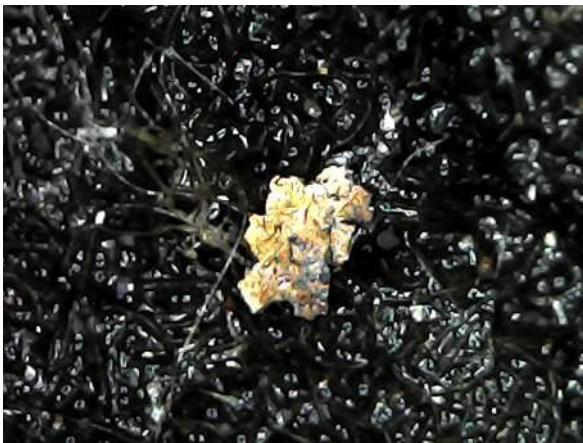
Copper-containing alloys, such as brass or bronze, vary from a light straw to copper color and will not react to a magnet.

Close-up of brass or bronze flake

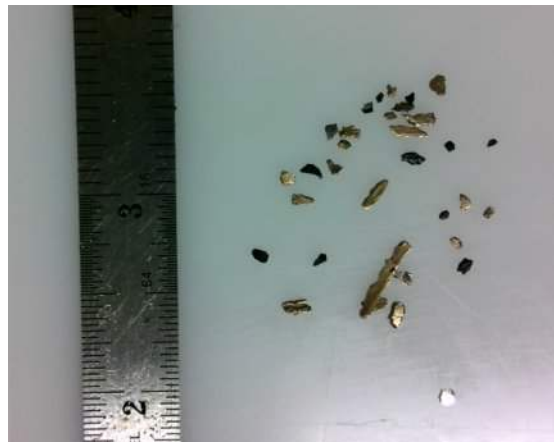
Mixture of brass/bronze particles and carbon

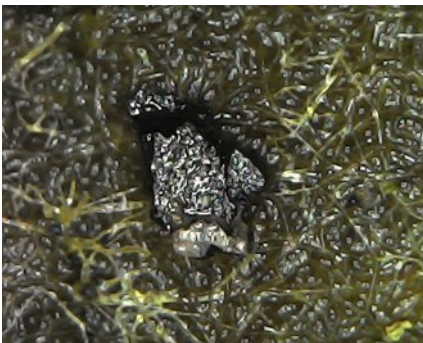
It is also common to find carbon, especially in the filters from turbocharged engines. Carbon looks like black, hard particles that can be broken apart between your fingers (see the pictures below). A large amount of carbon might indicate excess blow-by, but what counts as excessive is unique to each engine. Regularly checking the oil filter will give you a good idea of how much carbon is normal for your engine. You might find carbon with steel embedded in it, so it is good to check carbon particles with a magnet.

Close-up of carbon particle

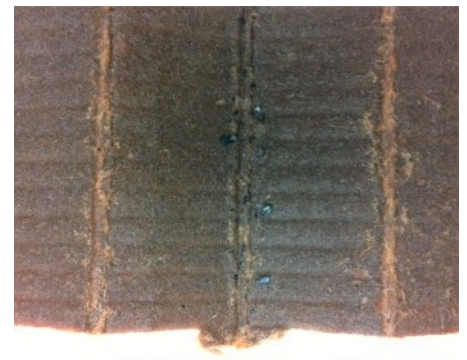
Carbon particles in filter pleat

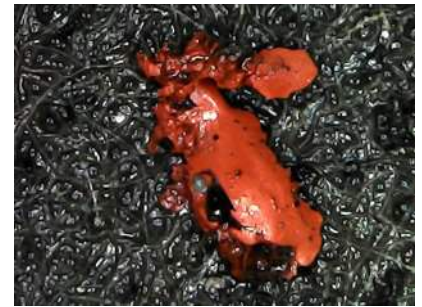
Small bits of sealer material may be found, especially after repairs. We generally don't worry about this sort of non-metallic debris.

Sealer material isn't typically worrisome

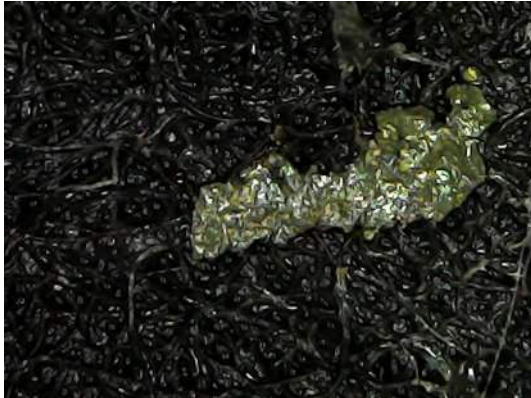
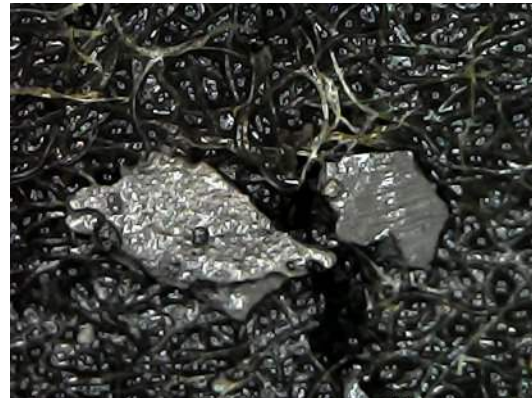
You might also find lead deposits from fuel blow-by. These particles have a bright, foil-like appearance that can look very much like a metallic wear particle. These deposits can be distinguished from metallic wear by their soft and "smudgy" texture. It is worth mentioning that these deposits are not lead from the wearing surface of a crank or camshaft bearing.

Both photos: lead deposits

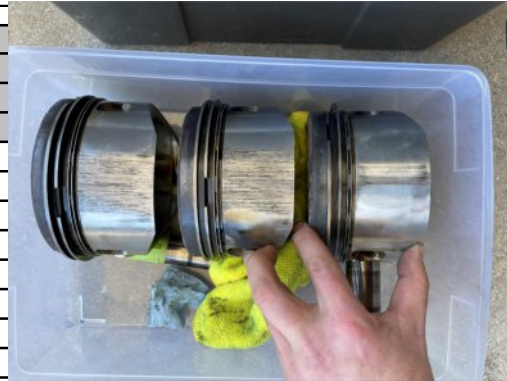
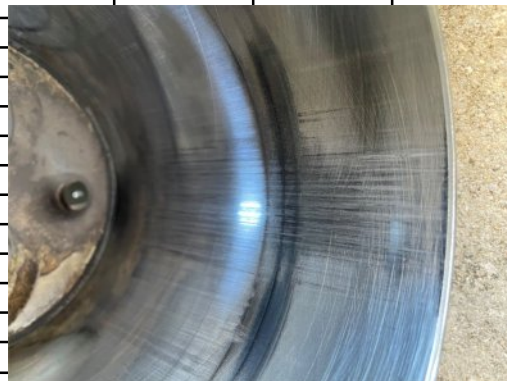
The owner knew something was obviously up when he got that first sample. In addition to metal in the oil report, the engine was seeing consistently high oil temps in cruise (210-230°F), and high CHT temps in #1 & #3 cylinders, as well as slightly rough running/vibrations in cruise & climb. Additionally, he reported, the engine felt very underpowered. "My engine is supposed to be rated at 160HP, but we had quite a difficult time getting off the water with two passengers, and one instructor who flew it said it felt like it had about as much power as his 100HP super cub. (His plane however is not on floats.)

The company who is inspecting and fixing/replacing my cylinders called me yesterday saying the following was wrong with my cylinders: the wrong piston rings were installed for chrome cylinders; heavy wear in every cylinder- scratches/gouges in #1 & #3 which tells him the plane likely sat for over a year in between startups; evidence of blow by in #1 & #3 - those cylinders also had small cracks developing; and several valves installed backwards (intake installed on exhaust side, & vice versa). He said this isn't a huge issue, but shows the laziness or inattention to detail by the mechanic who installed them (aka a warning sign that they did other things wrong, like use the completely wrong piston rings). So I'm having to get 2 new (reman'd) cylinders to replace the ones with cracks. And then he's overhauling everything else."

COMMENTS Thanks for discussing this sample with us on the phone. As you know, we're concerned about the amount of chrome this IO-320 is making. To give the engine some credit, chrome did improve nearly 400 ppm compared to the first sample, though the shorter run helped significantly. But at the same time, you only did a partial oil change after the first sample, so a good portion of the chrome could be carryover. We suggest 1. Compression test/borescope of cylinders 2. Looking into why the engine's running hot 3. Another run of 5 hours to see how chrome trends.

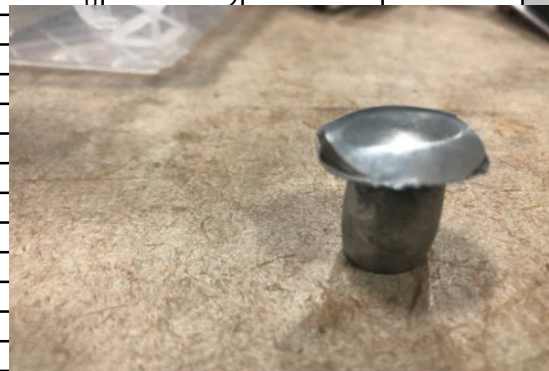
CLIENT The owner says: In reference to the oil analysis surprise of a week and a half ago and the loaded oil filter media, we found the source of the aluminum flakes - worn piston pin plugs. This single plug was from cylinder # 4 and two more were worn on cylinder # 2. Also, we think the (front) thrust bearing is worn beyond limits, allowing the crankshaft to move too much. Looks like a major overhaul is coming.

COMMENTS Thanks for noting the stuck exhaust valve. Aluminum is really high - high enough to show a problem. If temps got high in the cylinder with the stuck exhaust valve, aluminum could be the result. We are also seeing copper, which in this engine is often from piston pin plugs, connecting rod piston pin bushings, or wrist pin problems. With iron, copper can be from the starter adaptor. Maybe all this will improve now that you've freed the valve, but check for problems anyway. Borescope the cylinders and check compressions. Watch for metal.
