Inspecting Your Oil Filter

by Luke Miller, Senior Analyst

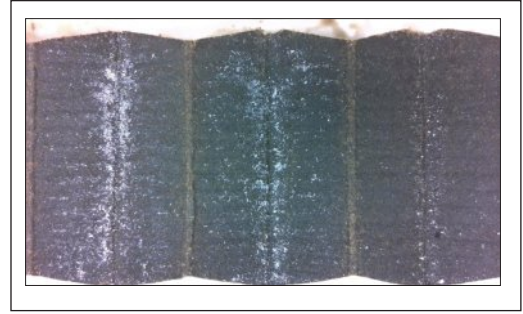
Severe aluminum particles in filter

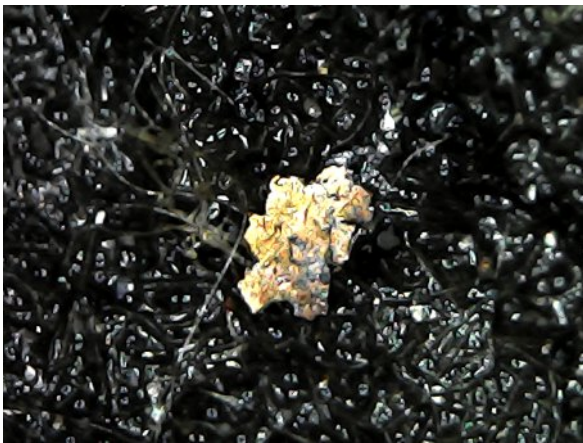
Copper-containing alloys, such as brass or bronze, vary from a light straw to copper color and will not react to a magnet.

Close-up of brass or bronze flake

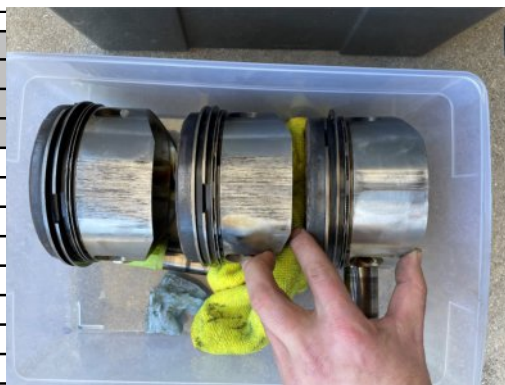
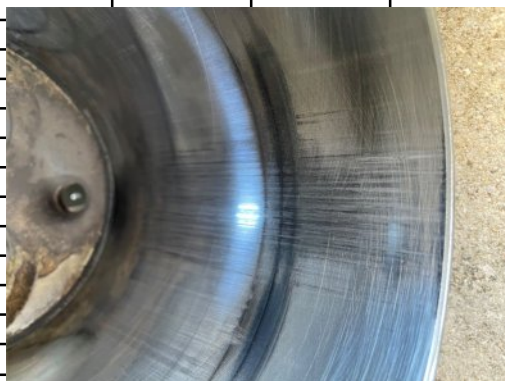
The company who is inspecting and fixing/replacing my cylinders called me yesterday saying the following was wrong with my cylinders: the wrong piston rings were installed for chrome cylinders; heavy wear in every cylinder- scratches/gouges in #1 & #3 which tells him the plane likely sat for over a year in between startups; evidence of blow by in #1 & #3 - those cylinders also had small cracks developing; and several valves installed backwards (intake installed on exhaust side, & vice versa). He said this isn't a huge issue, but shows the laziness or inattention to detail by the mechanic who installed them (aka a warning sign that they did other things wrong, like use the completely wrong piston rings). So I'm having to get 2 new (reman'd) cylinders to replace the ones with cracks. And then he's overhauling everything else."
