The Oil Report March 2024

Under Pressure: Part 2

An O-360, a stray paper towel, and a potential bearing problem

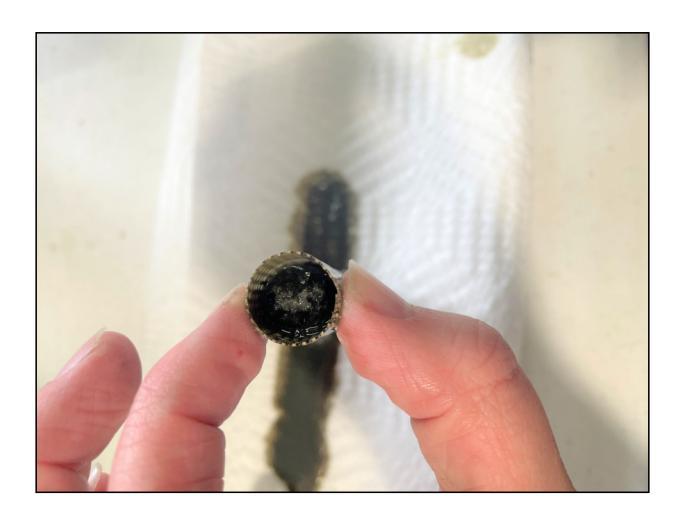
In Part 1 of this saga, our flying club's newly installed O-360 lost oil pressure in flight with a student pilot at the controls. After a fair amount of sweat and tears – but fortunately no blood – we found the engine had digested an errant paper towel, which was blocking the suction screen (see horrifying figure 1).

FIGURE 1: Suction screen and a paper towel: two things that do not play well together

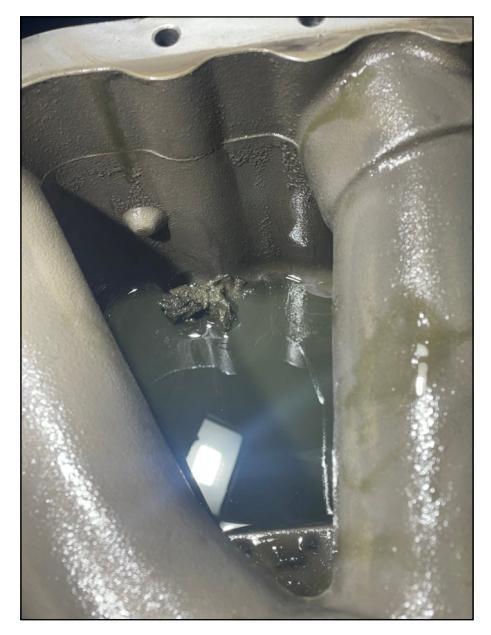
It took two solid days of work to remove, inspect, clean, and reinstall the oil pan, which still had paper towel in it (see figure 2, next page). Once that was done, after finding no large pieces of metal in the sump and being sure there wasn't any leftover paper towel in the engine, we did a 30-minute ground run

FIGURE 2: The oil sump/pan, with paper towel lingering in it

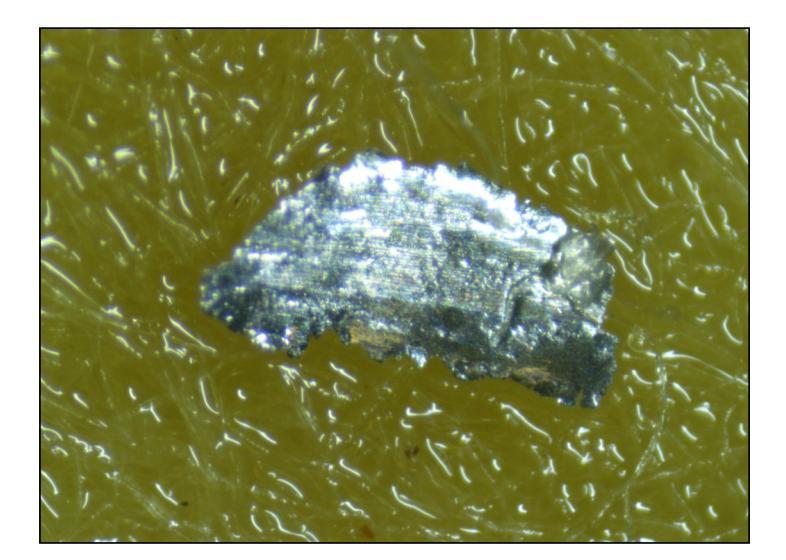
The oil analysis was unremarkable, but the oil filter report noted 10-15 non-ferrous metallic flakes per pleat with a few dozen larger pieces that had scrape marks on them (see figure 3). This filter was a little better than before, but certainly not clean. But this was only a 30-minute ground run compared to the 20-some hour sample. Were the improvements from the shorter oil change or an actual improvement? We didn't know.

FIGURE 3: Metal from the filter

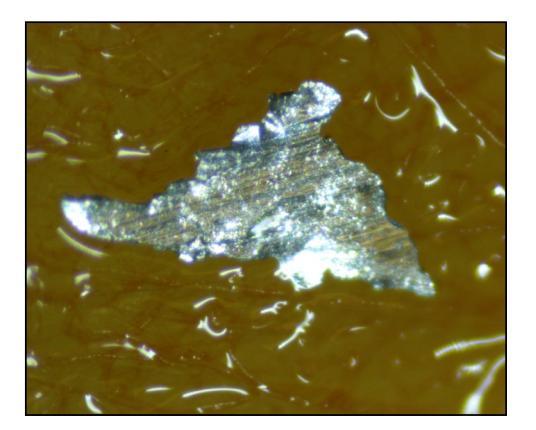
The oil analysis was unremarkable, but the filter – not great (figure 4, next page). Approximately 30 variously sized non-ferrous flakes were present per pleat, along with one piece of steel.

Instead, we received the disheartening news that "the overall quantity and size of the non-ferrous flakes was similar to the previous filter" (figure 4). *Dang*.

Figure 4: Still with the filter metal

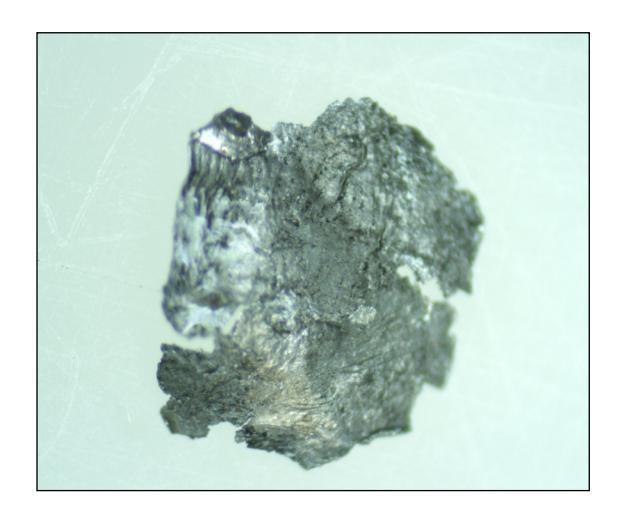
Figure 5: Will the metal ever end?
