## Report of the Month

Something went wrong in this F150's 5.4L V-8 engine. Can you figure out what?

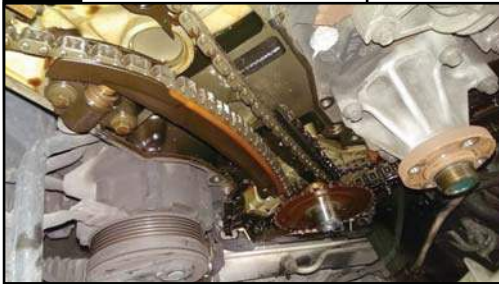
Broken timing chain tensioner

Although the engine had a slight rattle dating back to 37,000 miles, his wear numbers were okay for years before things went south. The noise progressed to an occasionally much longer rattle just before the December oil change, and when wear shot up in analysis the owner decided to take a closer look. Less than three hours after taking it into a shop, he got a call from the mechanic, who couldn't believe how lucky the guy was. "Half of the tensioner assembly broke and fell down into the oil pan. This allowed a significant amount of slip in the timing chain, which allowed the chain to "machine" the inside of the timing cover. He was surprised the chain was still on the sprockets. Had it fallen off, the pistons on that side would have made sweet, sweet love to the valves in that head, leaving me with four operable cylinders until the loose chain worked its way into the operating chain, to finish off the whole mess in a bang. All related timing chain parts for both banks are being replaced now. Without the oil test in December 2013, I would have just kept on driving until something catastrophic happened. Thanks for your help!"

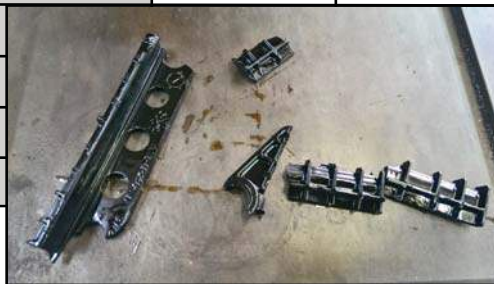
Tensioner, removed

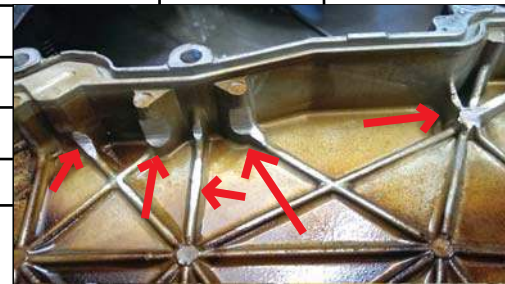
The worn timing chain cover
