Report of the Month

Something went wrong in this F150's 5.4L V-8 engine. Can you figure out what?

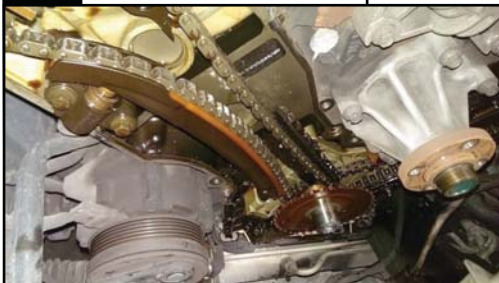
Broken timing chain tensioner

Although the engine had a slight rattle dating back to 37,000 miles, his wear numbers were okay for years before things went south. The noise progressed to an occasionally much longer rattle just before the December oil change, and when wear shot up in analysis the owner decided to take a closer look. Less than three hours after taking it into a shop, he got a call from the mechanic, who couldn't believe how lucky the guy was. "Half of the tensioner assembly broke and fell down into the oil pan. This allowed a significant amount of slip in the timing chain, which allowed the chain to "machine" the inside of the timing cover. He was surprised the chain was still on the sprockets. Had it fallen off, the pistons on that side would have made sweet, sweet love to the valves in that head, leaving me with four operable cylinders until the loose chain worked its way into the operating chain, to finish off the whole mess in a bang. All related timing chain parts for both banks are being replaced now. Without the oil test in December 2013, I would have just kept on driving until something catastrophic happened. Thanks for your help!"

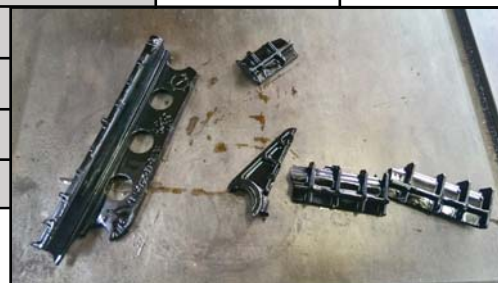
Tensioner, removed
