Report of the Month

This 1945 Pratt & Whitney R-2800 engine failed in flight. Can you tell what went wrong?

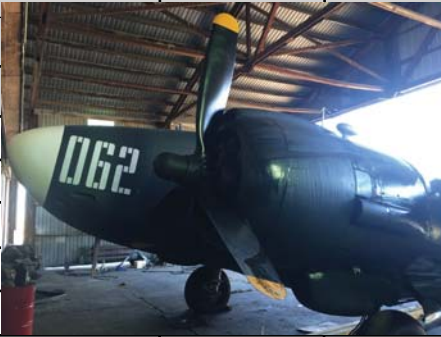
The Lockheed R2800 in question.

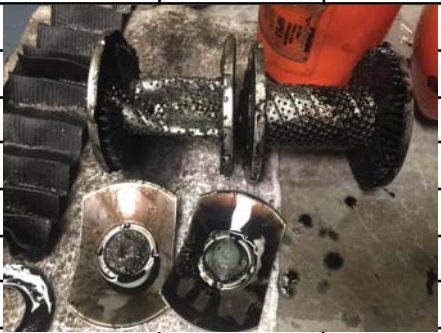
The paper filter element jammed up with metal from the failed bearing, and then the metal jammed up the bypass element too. Pictured is a comparison between the crushed filter element and a normal one.

This engine suffered a bearing failure - a problem that's difficult for us to see in analysis, because any lead coming from bearing babbitt is masked by lead from 100LL. What we do see, though, is elevated bronze wear (copper and tin). The pilot says: "I was flying over the Sierras in a really bad spot that necessitated using the engine to get as much altitude and distance from the mountains as possible. As soon as power was reduced I knew it was going to seize and sure enough it did. As to why it failed, there could be many causes. This new engine was built by Ford in 1945 and was never used. It was put on this aircraft in 1994, flew 20 hours, and then sat for 16 years. It ran well. We could see a history of left engine failures in the sludge on the bottom of the oil tank that we cleaned. Maybe some of this found its way through the oil system and scored the main bearing. Or maybe sitting for 16/70 years caused long-term issues with the main bearing. Or maybe a Japanese spy was working in the P&W plant in 1945...just kidding! Anyway we are all okay. It was a good day."

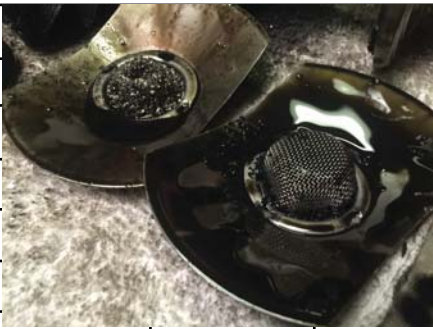
The screen dome around the bypass valve was mashed flat by the hydraulic action of the scavenge oil.
