## Inspecting Your Oil Filter

by Luke Miller, Senior Analyst

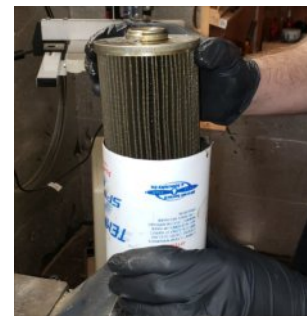
3. Once the lid has been cut, the cartridge with pleats can then be removed from

the housing. It is also good to inspect the inside of the filter housing for metallic particles and other debris that may not be trapped in the filter pleats.

3. Cutting the filter lid and removing the pleats.

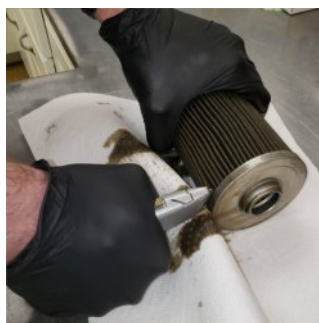
4. Cutting the filter pleats.

2. Hold the knife with your knuckles against the bench for stability. Starting at the seam and using only downward force, cut along the edge of the pleats opposite the side you are holding. We prefer to rotate the pleats into the knife blade, firmly holding the knife in a fixed position. This method, when done properly, protects your fingers from the knife blade, where the knife moves downward into the bench if it were to slip.

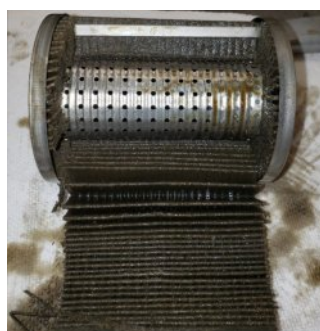
4. Again locate the seam where the two ends of the filter pleats are joined together. Cut across the pleats on either side of the seam.

5. Cut pleats in the valley next to the filter seam (metal band) to remove.

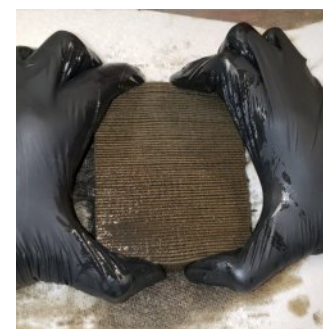
6. The pleats will still contain a fair amount of oil at this point. If time allows, you can place the pleats on paper towels to drain overnight. You can also squeeze the pleats like an accordion and mop up the oil that squeezes out with paper towels.

6. Squeeze pleats to remove oil if necessary.

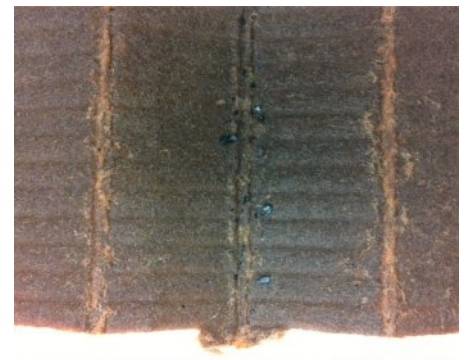
It is also common to find carbon, especially in the filters from turbocharged engines. Carbon looks like black, hard particles that can be broken apart between your fingers (see the pictures below). A large amount of carbon might indicate excess blow-by, but what counts as excessive is unique to each engine. Regularly checking the oil filter will give you a good idea of how much carbon is normal for your engine. You might find carbon with steel embedded in it, so it is good to check carbon particles with a magnet.

Carbon particles in filter pleat

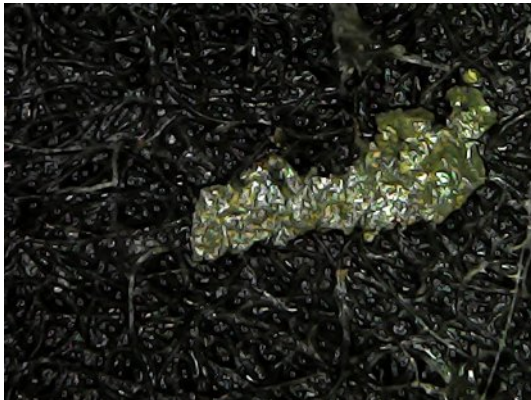
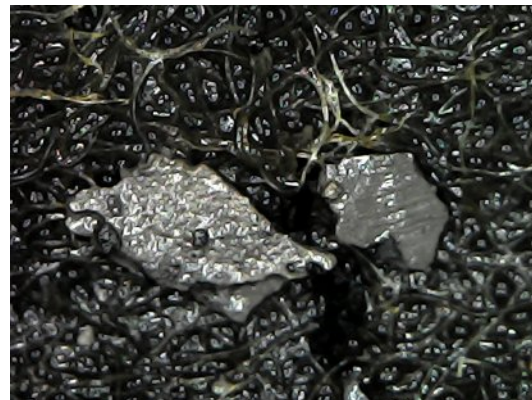
You might also find lead deposits from fuel blow-by. These particles have a bright, foil-like appearance that can look very much like a metallic wear particle. These deposits can be distinguished from metallic wear by their soft and "smudgy" texture. It is worth mentioning that these deposits are not lead from the wearing surface of a crank or camshaft bearing.

Both photos: lead deposits
