The Oil Report July 2022

Under Pressure

A flying club figures out what to do when things go haywire

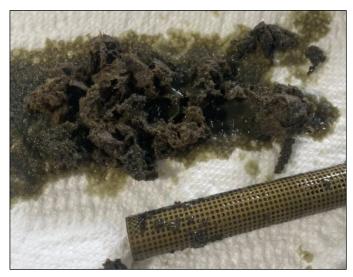
Fig. 5: After we pried the debris out

Later that night, with the oil drained, the filter cut and the oil pressure relief valve not the suspect, I pulled the oil suction screen. My heart sank. The screen was completely blocked by fibrous material. It looked like the same stuff we found in our earlier oil change, only a whole lot more of it. The pickup screen was so caked full that I had to use a screwdriver to push the debris out of the screen (figures 4 and 5).
