The Oil Report March 2024

Under Pressure: Part 2

An O-360, a stray paper towel, and a potential bearing problem

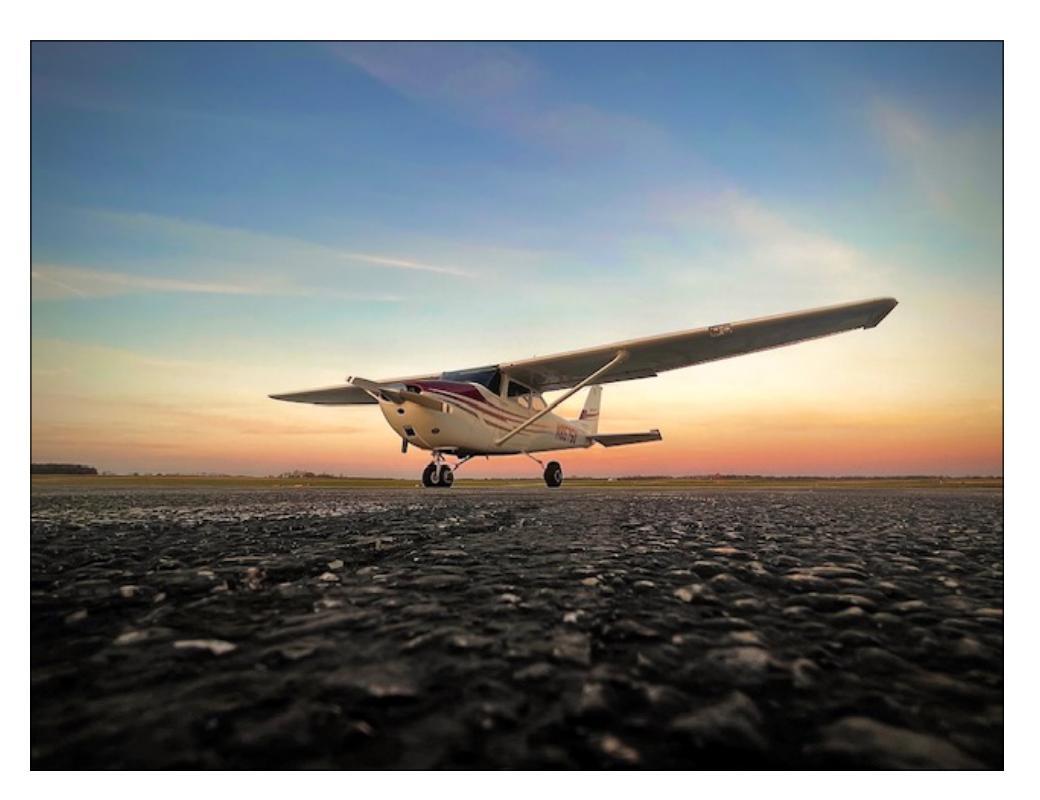
Editor's Note: The flying club's Cessna is still flying today, and the engine has made a full recovery from the Great Paper Towel Incident of 2022-23.

A happy ending!
