### Report of the Month

This 2012 Mustang's problem wasn't immediately obvious, but it's there. What's wrong?

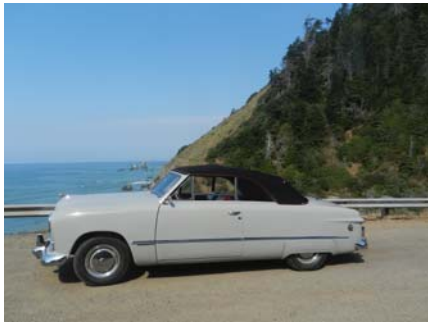
ELEMENTS IN PARTS PER MILLION	MI/HR on Oil	8,100	UNIT/ LOCATION AVERAGES

UNIVERSAL AVERAGES
	MI/HR on Unit	25,000			
	Sample Date	9/28/2017			
	ALUMINUM	6	6		5
	CHROME	3	3		1
	IRON	112	112		44
	COPPER	12	12		18
	LEAD	22	22		82
	TIN	0	0		2
	MOLYBDENUM	85	85		73
NICKEL	1	1	0		
POTASSIUM	0	0	9		
BORON	53	53	42		
SILICON	9	9	14		
SODIUM	33	33	110		
CALCIUM	1399	1399	2062		
MAGNESIUM	740	740	117		
PHOSPHORUS	758	758	1381		
ZINC	900	900	1537		
BARIUM	1	1	1

VALUES SHOULD BE*	
SUS Viscosity @210°F	80.3      58-68
cSt Viscosity @ 100°C	15.60      9.7-12.7
Flashpoint in °F	365      >365
Fuel %	TR      <2.0
Antifreeze %	0.0      0.0
Insolubles %	0.2      <0.6

From the owner: In September 2017 I embarked on a trip across The Great Northern Route Two to the Western National Meet of the early Ford V8 Club of America in Salem, Oregon. The route goes from Bar Harbor, Maine to Everett, Washington. Other than a couple of cities it is basically rural -- there may be speed limit signs, but not much else.
