## Report of the Month

This Subaru STi has seen better days. Can you tell what's ailing it? Hint: There are pictures below that show the damage.

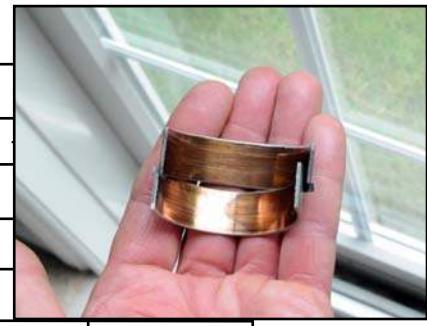
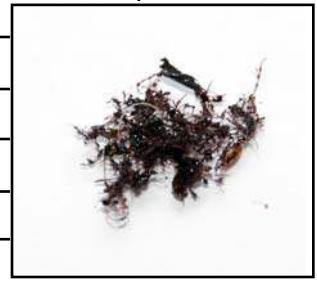
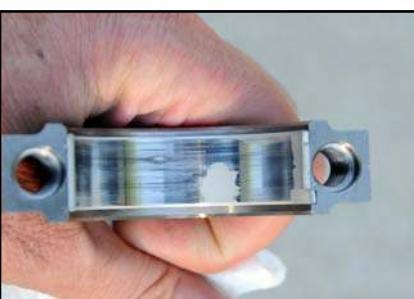
This STi mostly sees street use, with a little racing thrown in at times. A little bearing wear started showing up in the May 2013 sample, and soon thereafter the owner noticed a 10 psi loss in oil pressure. He was concerned about bearing damage, and indeed, the June report showed much higher levels of copper, lead, and tin. He split the case and found damage to all the bearings (one worse than the others). He also found a small piece of something that looked abrasive in the oil pickup screen, which turned out to be a small piece of Scotch Brite pad. The damage was due to too-tight main bearing clearances for the RPMs he's running, as well as a dirty build -- contamination in the block while the engine was being built. He's rebuilding the engine and hopes to have it running in July.
