The Oil Report February 2019

Do I Need to Worry?

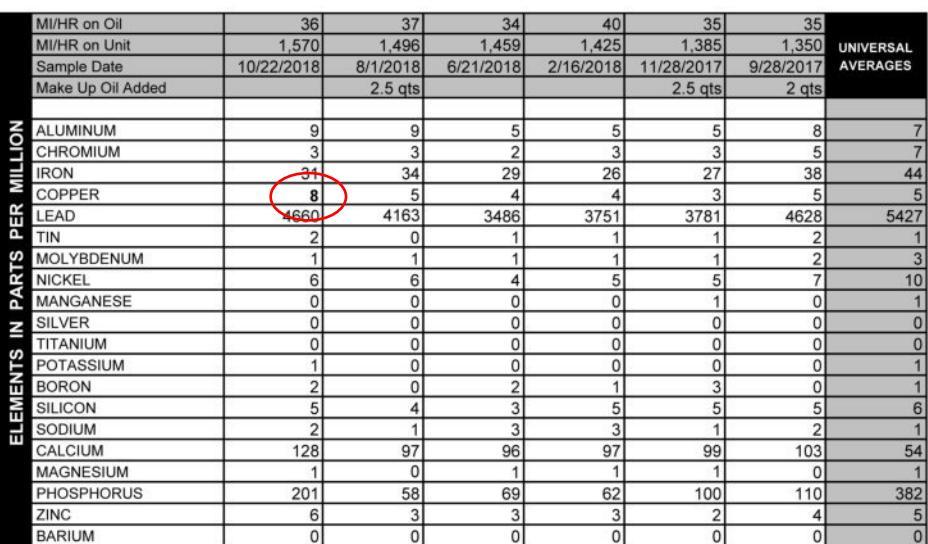
Figure 2: Continental IO-550-N27

But on the other hand, look at Figure 2. Copper (from brass/bronze parts like bushings and bearings) wasn't unusually high compared to averages for this IO-550-N27, but it was higher than before, and as such we flagged it as something to monitor

The increase in copper is worth watching, even if the level isn't high.
