Oil the News that's Fit to Print!

Report of the Month

Note the change in aluminum. What's going on in this Superior XPIO-360 engine?
This is a hard one to figure out.

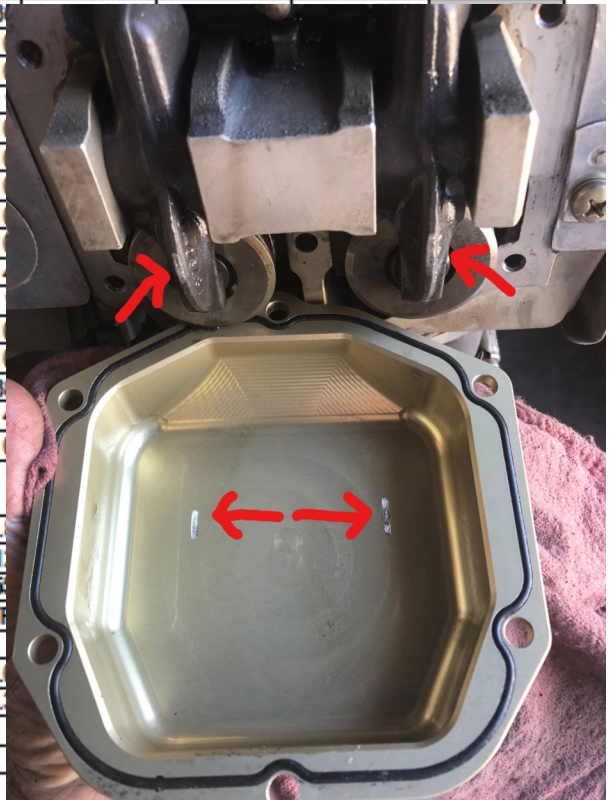
CLIENT The owner bought a set of aftermarket valve covers. Unfortunately the manufacturer of the covers did not realize that Superior cylinders have taller rocker arms, which interfered with the covers. He discovered the problem when he spotted hairline cracks on the outside of the covers at oil change time. In the photo you can see the grooves cut in the covers by the rockers, and the burnished marks on the rockers themselves. He went back to stock steel covers.

COMMENTS You hit the nail on the head with this sample -- aluminum did read high. It read unusually high compared with past trends, and we were just starting to wonder what would cause that when we read your note. The good news is that the aluminum didn't appear to make the oil abrasive -- everything else looks very good compared to both averages and trends. We'll look for aluminum to improve over the next couple of samples, since it sounds like you already figured out what was going on. If you have any pictures, we'd love to see. No fuel/water found.
